## **Abstract**

The cliffs above the public beaches of the Conero Riviera between Ancona and Portonovo, Italy, are comprised of sedimentary rocks and are subject to copious rainfall and occasional earthquakes. The area has experienced large-scale landslide events, from Portonovo's 14th century landslide to Ancona's more recent 1982 landslide. Though these events have been studied at length, there are no studies on this region's risk of future landslides. Based on the historical and geological evidence, it is important that the Ancona coastline be assessed for landslide risk. This study aimed to determine the role of geologic structures in the area near these two historic landslides using kinematic analysis as well as structural and stratigraphic field data collected between the Ancona shipyard and the southernmost accessible beach of Monte Conero. We collected data from within several different rock units and observed distinct patterns of jointing, faulting, and bedding along the coast. Some of these structures show risk of planar and wedge failure. There is evidence of recent rockfalls and landslides, all of which were smaller than the two historical slides. We conclude that the

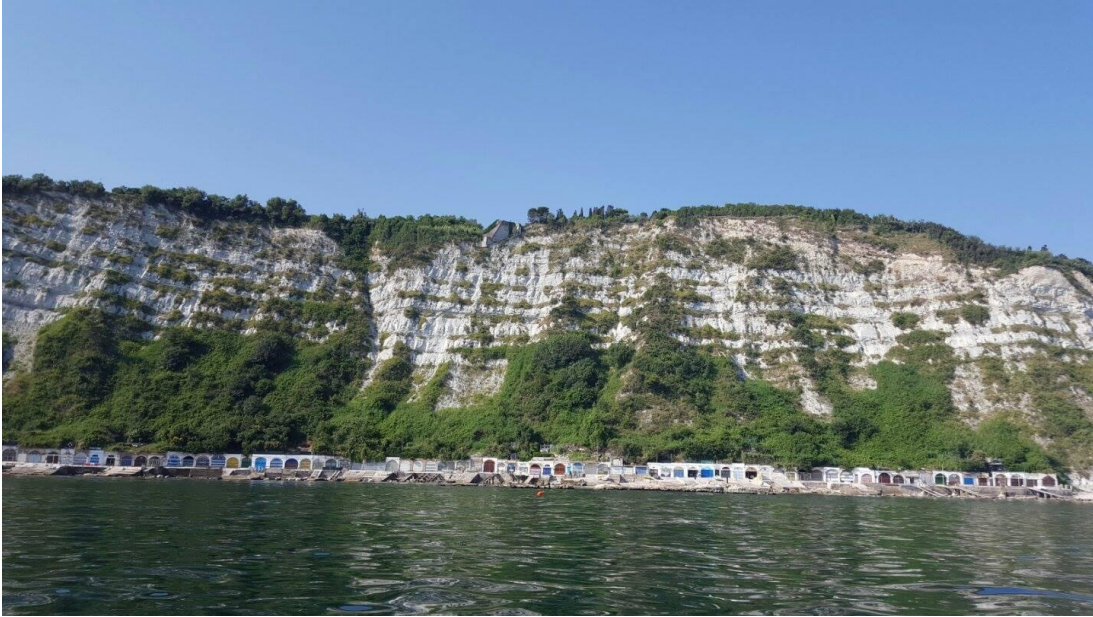
Figure 4 The Miocene Schlier limestone unit above boat houses carved into the cliffs of the Conero Riviera.

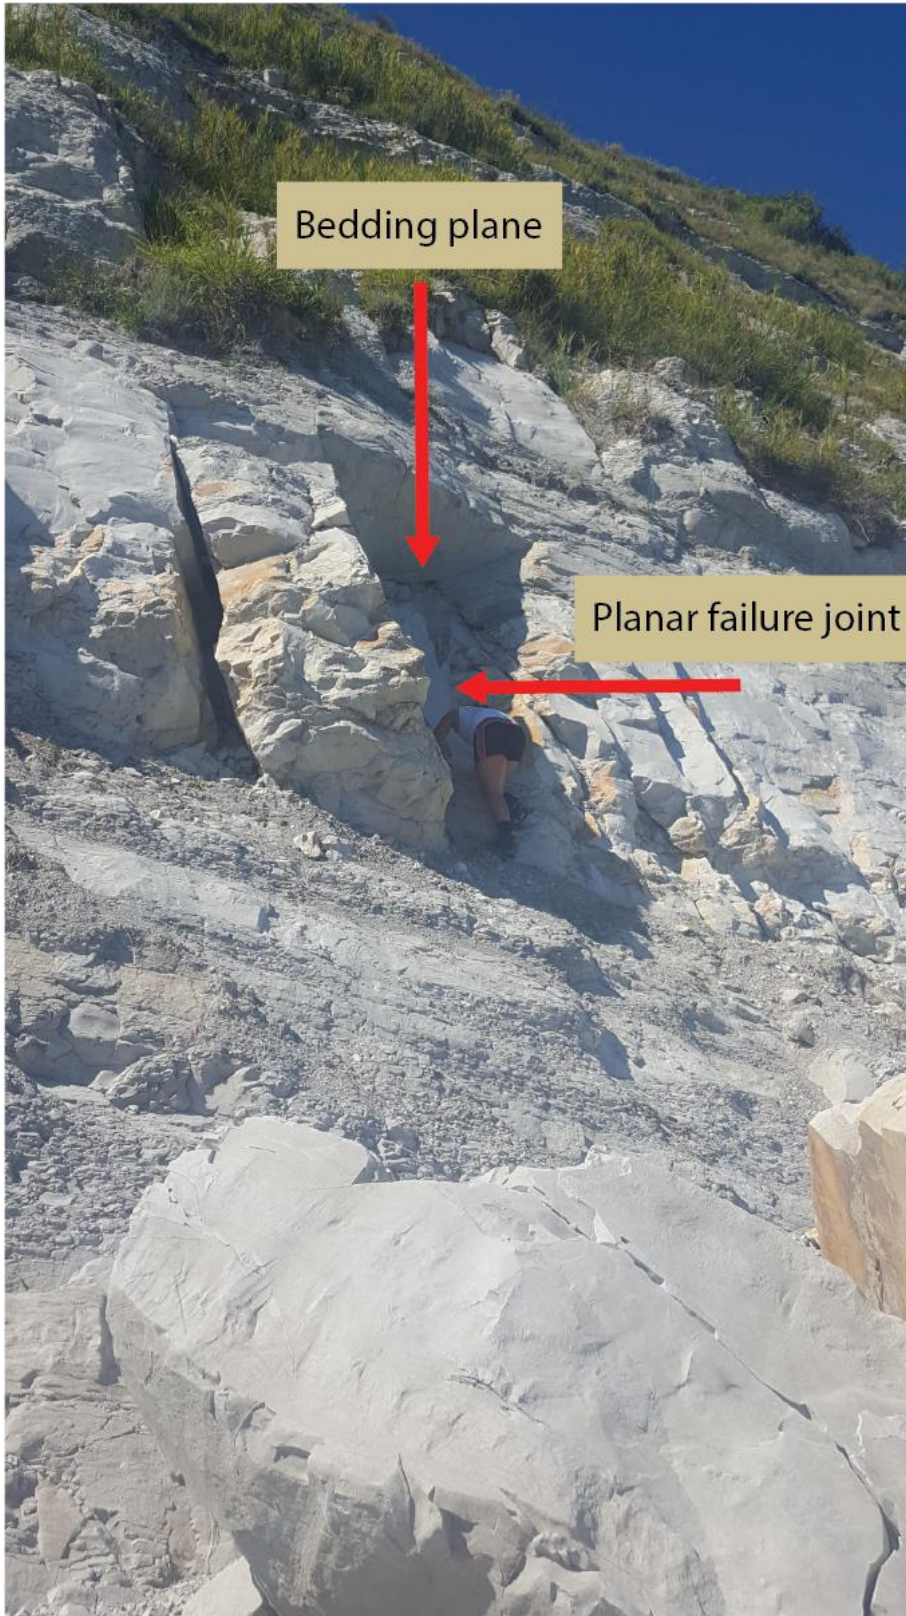
These areas had two sets of pervasive joints. Several instances of block falls caused by the two joint families were found (Figure 9, Figure 10). Two types of past landsliding can be seen in this area: falls of large boulders and cobbles from various heights on the cliff and low volume landslides of sand to cobble sized clasts.

The style of landsliding at locations 1a-c is similar despite these locations having different orientations of joints. The weathering style of the Schlier layer, which leaves every other bed jutting out of the cliff without support, plays a part in the gravel to boulder sized rock falls which detach from varying heights on the cliffs (Figure 9 and Figure 10). As the weak

layers erode away, larger and larger volumes of the strong layers are left jutting out of the cliff side with no underlying support. These areas are prone to rockfall events from any height up the cliffs.

Figure 9 Planar failure along a joint plane of a Schlier limestone block near the Ancona shipyard.

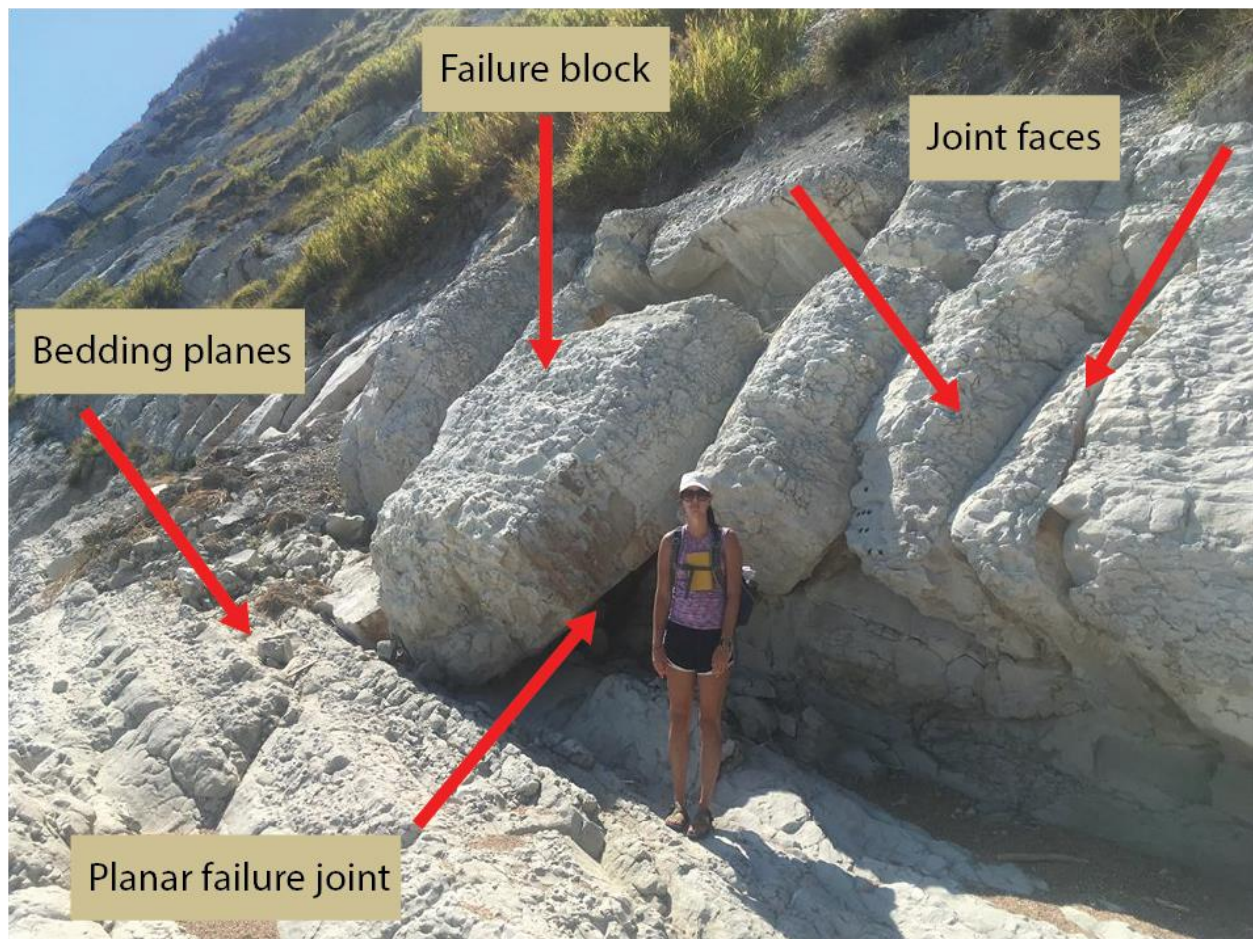
Figure 10 Planar failure along a joint plane of a block of Bisciaro limestone near the Ancona shipyard.

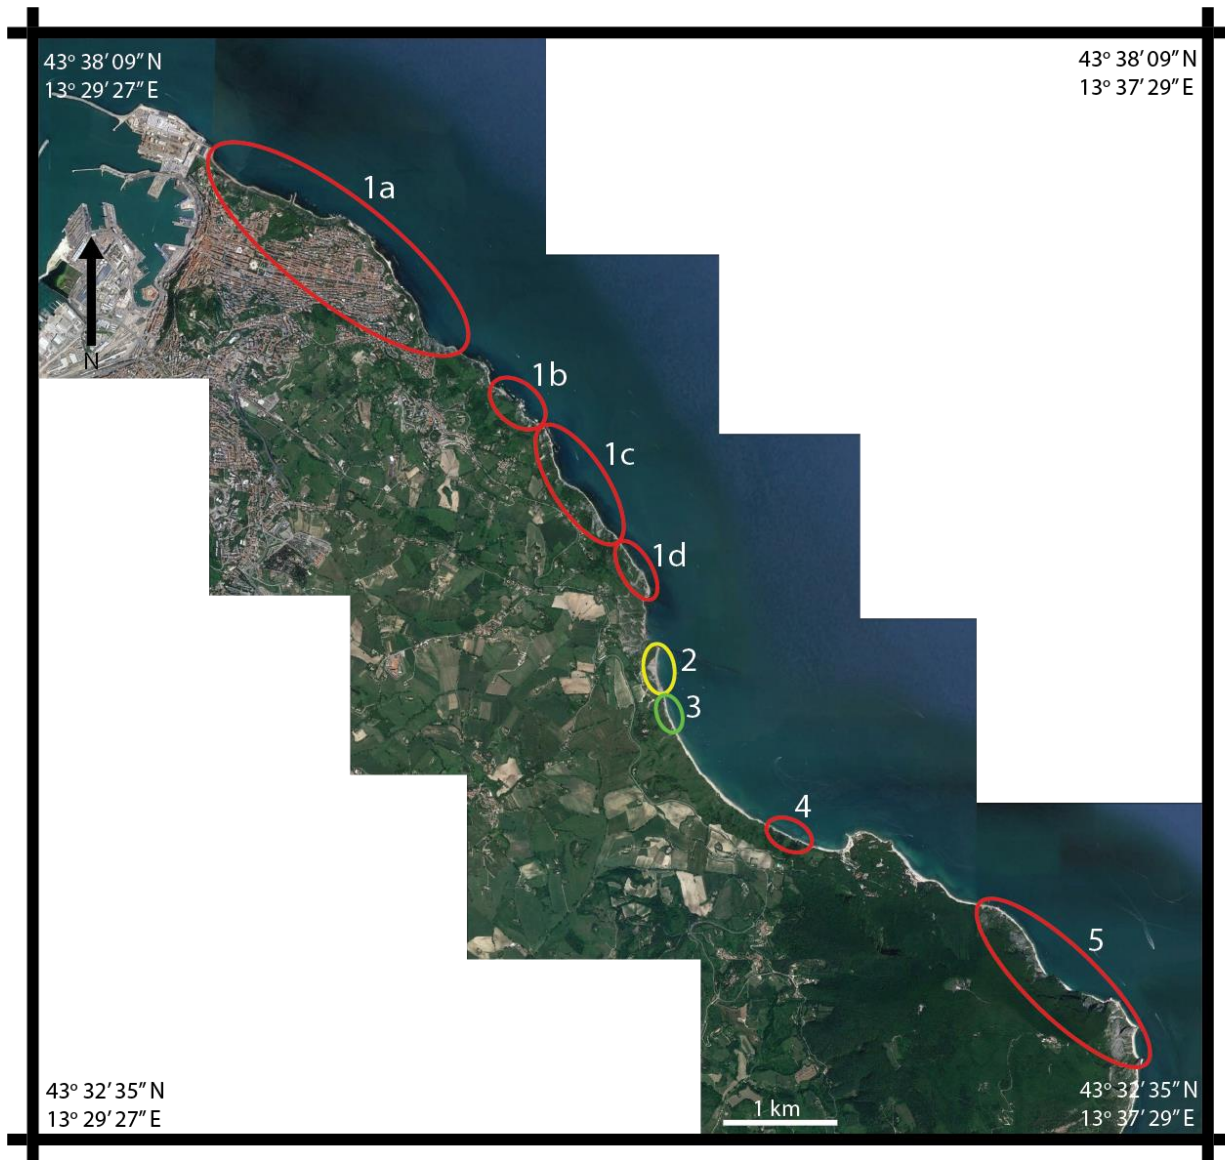
Based on the number of failure types at each location, locations 1a-d, 4, and 5 are the highest landslide risk regions as they show both planar and wedge failure risk. Within locations 1a-d, 1a and 1d are at higher risk levels than 1b and 1c because a larger total proportion of their joints are oriented for failure than the joints in 1b-c. Locations 2 is at moderate risk level with planar failure risk of its joints. Location 3 has no structures oriented for kinematic failure. Relative landslide risk can be seen in Figure 11.

Figure 11 Relative risk map. Red outlines indicate highest risk of kinematic failure induced landslides. Yellow indicates intermediate risk, and green indicates low risk. Areas in red are at risk of wedge and planar failure. The area in yellow is at risk of planar failure. And the area in green has no kinematic risk.

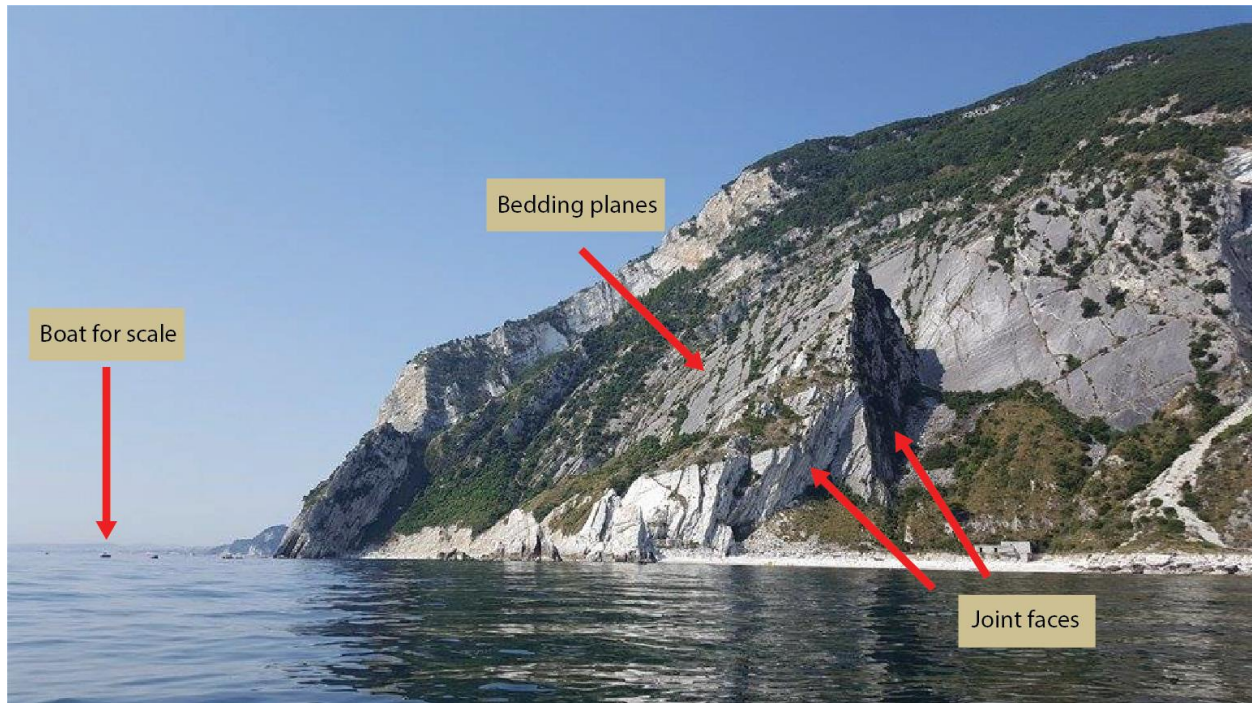
Location 5 shows risk of planar failure along bedding planes. There are detachment scars up to approximately 275m elevation above hundreds of square meters of exposed bedding planes

(Figure 12). While this region is at risk of both planar and wedge failure, the majority of failure planes are oriented for planar failure. Almost all of the bedding planes are oriented for planar failure, while only about one third of the joints and stylolites are oriented for wedge failure. Thus, a planar failure slide is more likely to occur here than a wedge failure slide. This area is susceptible to cobble to boulder sized pieces of rock as well as large sheets of bedding plane-failing from high elevation. Since the cliffs here are much higher than anywhere else in the study area, location 5 could produce a slide of a much larger volume of rock than the other locations exhibiting two failure types.

Figure 12 Exposed bedding planes oriented for planar failure, detachment scars, and joints on Monte Conero at the southernmost end of the field area.
