SURVEY AND MAPPING OF THE FRED GRAVES SITE:  
LAYING THE GROUNDWORK FOR UNDERSTANDING A RURAL NON-PLANTATION-  
BASED SOUTHERN COMMUNITY

Honors Thesis  
Curriculum in Archaeology  
University of North Carolina at Chapel Hill

2018

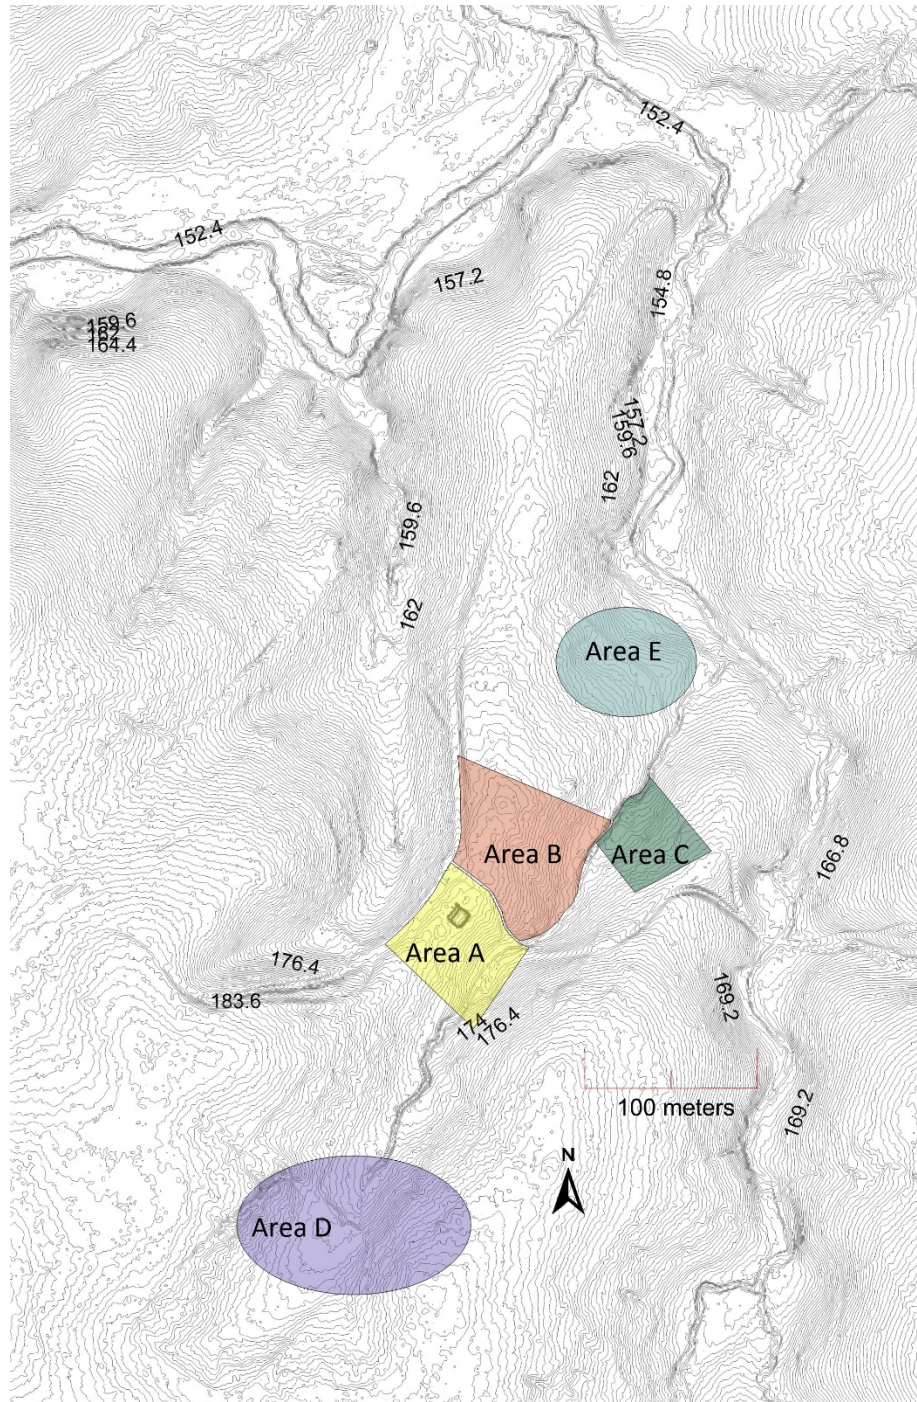
Figure 1. Contour map created from LiDAR data. Contour intervals are 30 cm. Fred Graves site is indicated by Areas, A, B, C, D, and E. Stinking Quarter Creek is at the top.

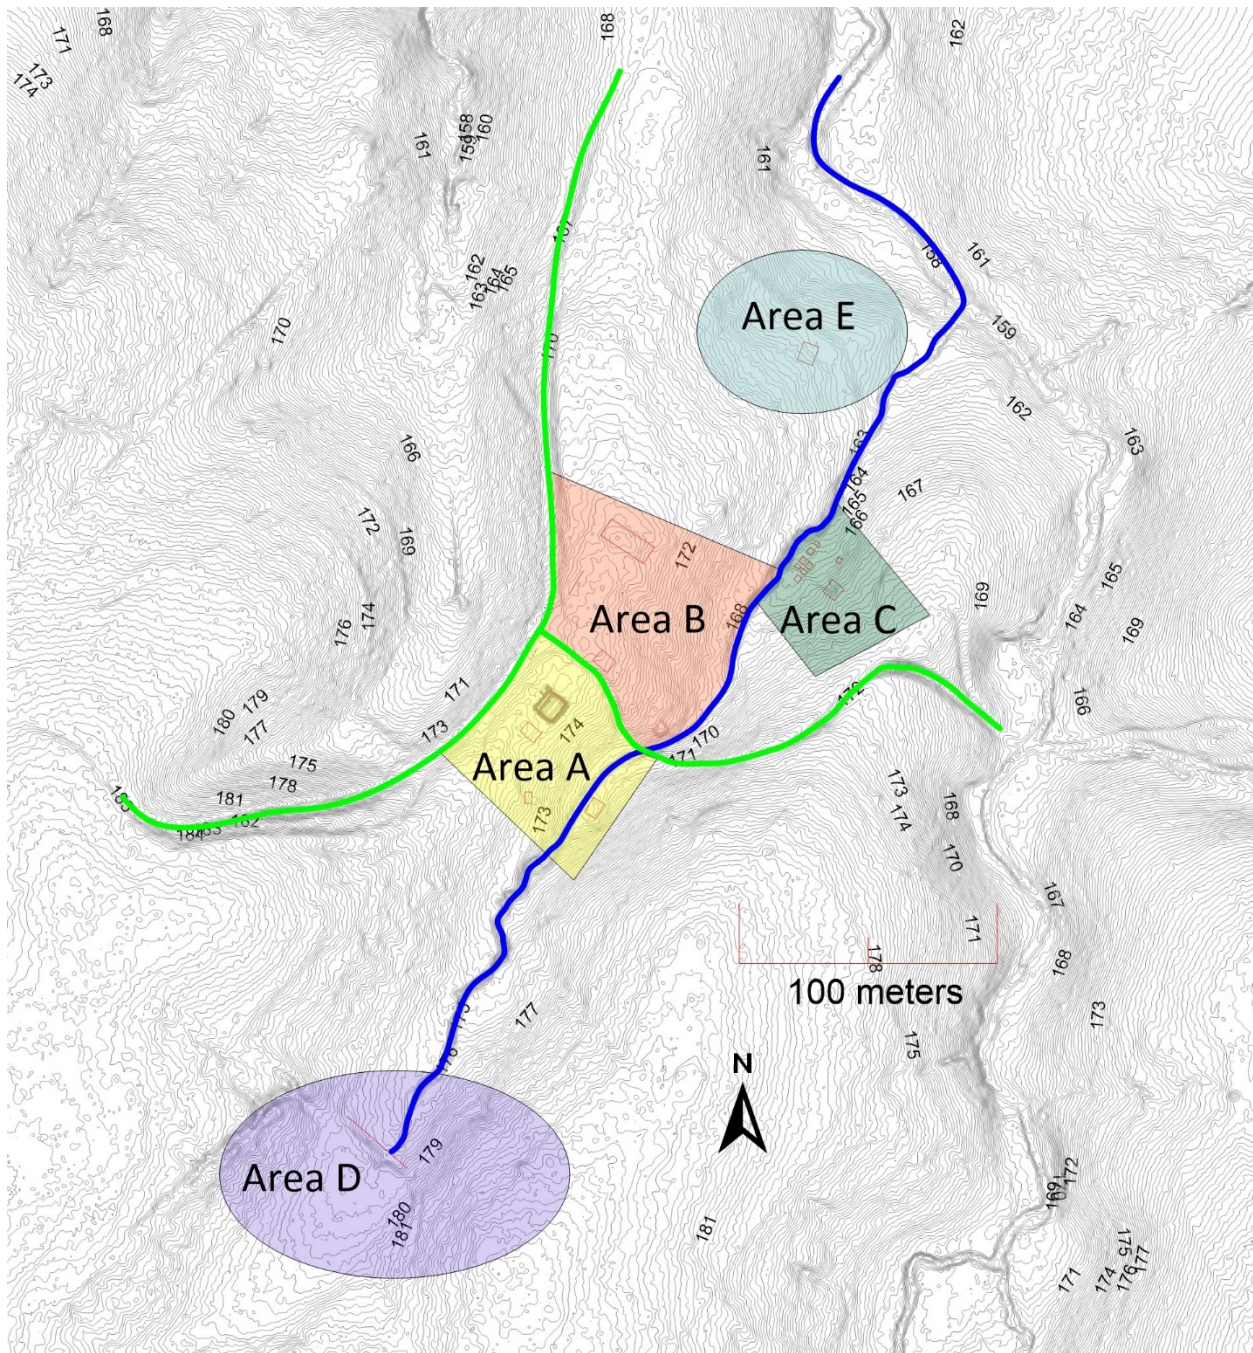
Figure 7. Contour map created from LiDAR data. Contour intervals are 20 cm. Roadbeds in green. Stream in blue.

The site is located east of a roadbed, which runs north-south in front of Structures 1 and 2. Another roadbed travels east, cutting through the site, and crosses the small stream that flows south to north toward Stinking Quarter Creek. Area A is south of the road and includes Structures 1, 2, 3, 4, and 5. North of the road, within Area B, are Structures 6, 7, 8, and 9. Areas A and B are somewhat clustered together between the north-south roadbed and the stream. East of the stream and just north of Areas A and B lies Area C. This area includes Structures 11 and 12 as well as a group of seven pits designated as Structure 10. Southwest of Area A, and south of all other structures, is Area D. Area D includes only Structure 13. Area E is at the northernmost edge of the Fred Graves site and consists of a single feature, Structure 14.

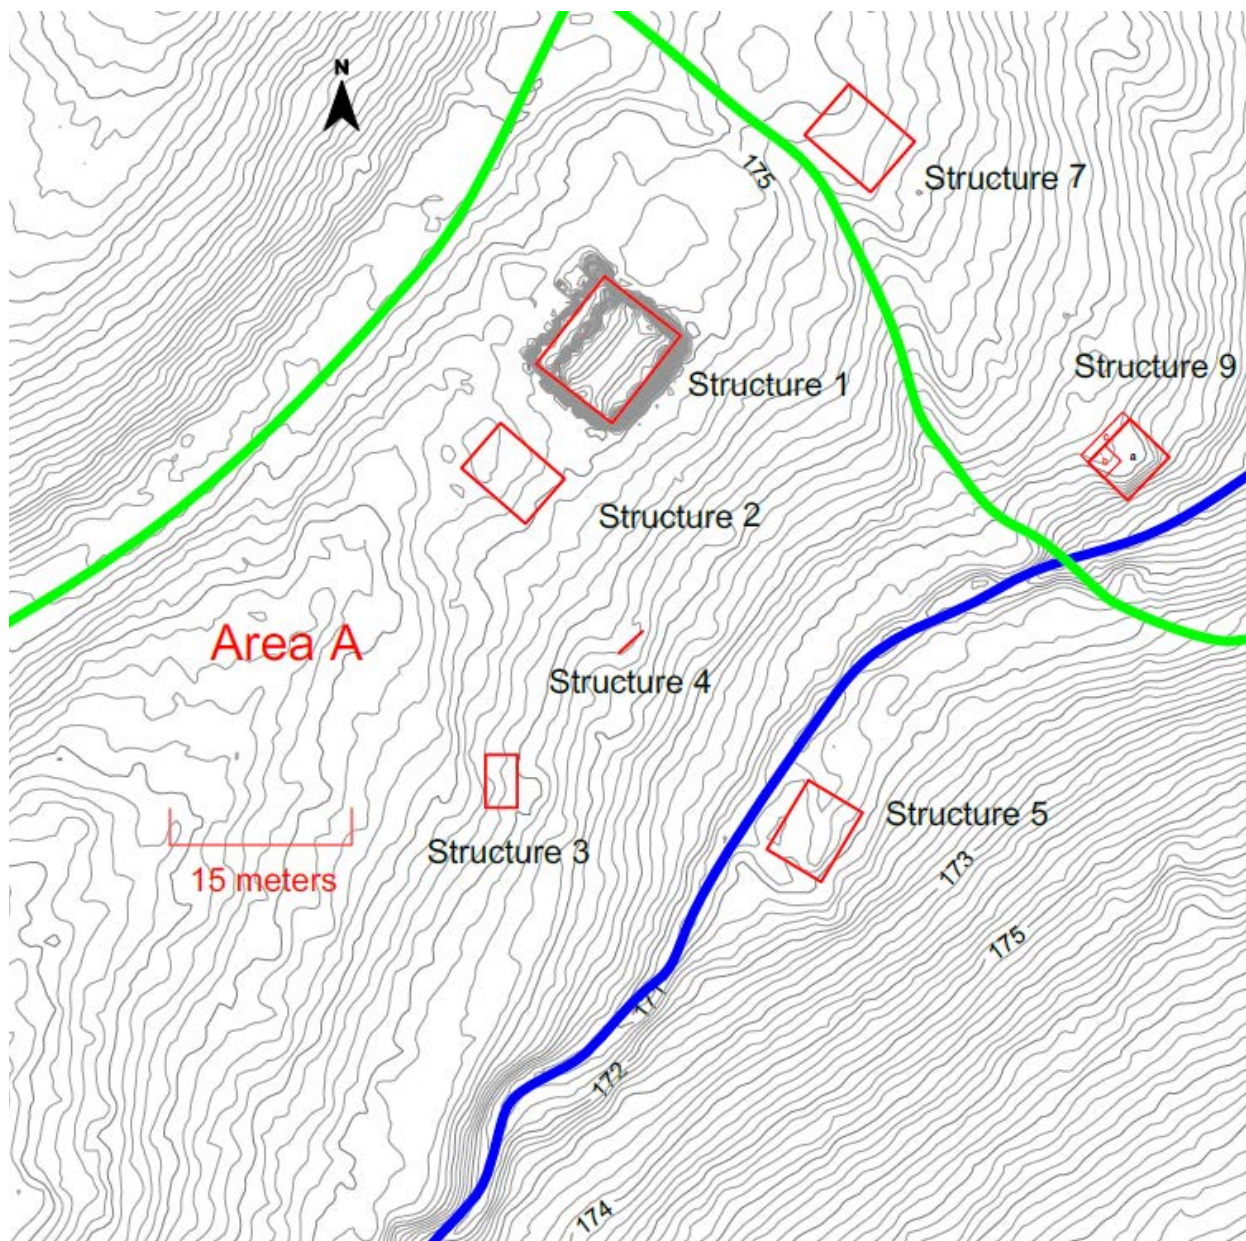
Figure 8. Contour map of Area A. Structures in red, roadbeds in green, and stream in blue. Contour intervals 20 cm.

Area A encompasses an area approximately .29 hectare (or about .71 acre) and is bounded by a stream to the east, a roadbed to the west, and a roadbed to the north (Figure 8). This is the largest area of the surveyed site and contained the most structures. The land within Area A slopes downhill from the roadbed towards the creek. The ground is thickly covered with the non-native plant periwinkle, which thins the further one gets from Structure 1. All structures are west of the stream with the exception of Structure 5. Structure 5 is just across the stream.

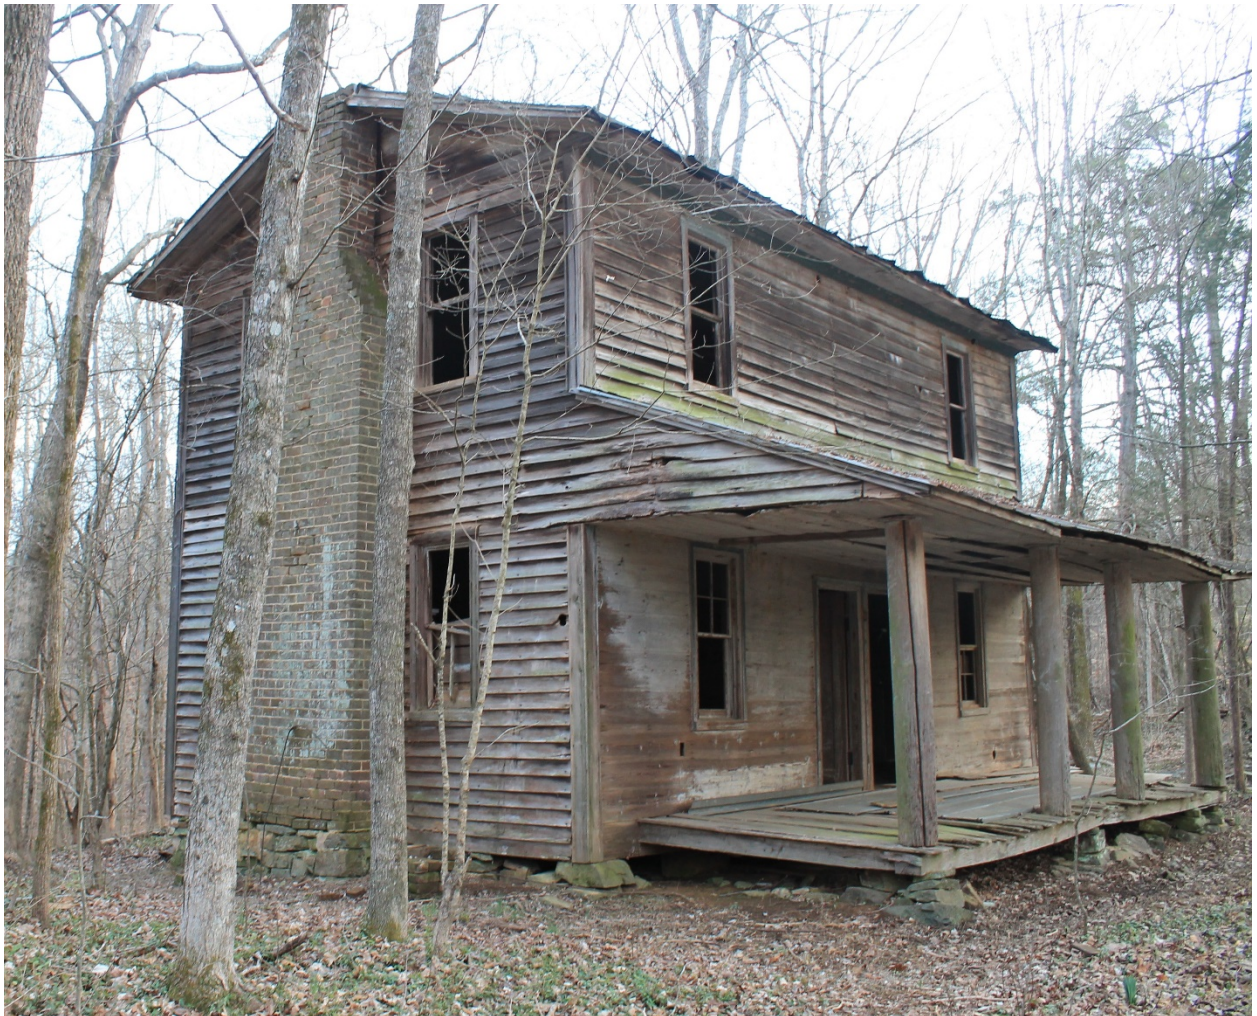
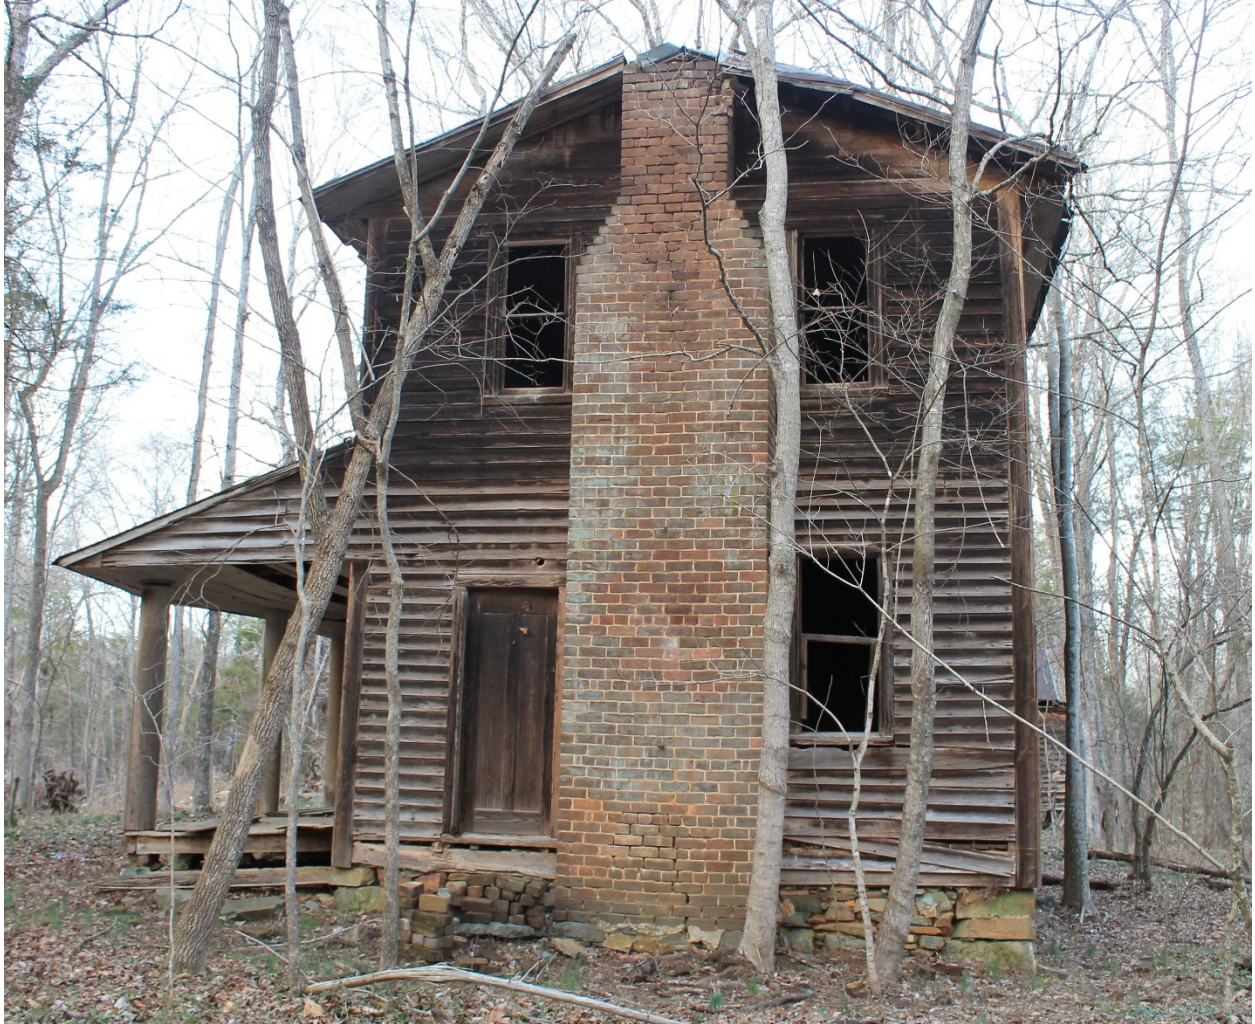
a covered porch at the front entryway and the porch roof is supported by four Doric-styled columns. As can be seen from Figure 9 and Figure 10, the building is in good shape considering it has been abandoned for 90 years. The only upkeep known to have been done to the building since 1928 is the addition of new metal on the roof. The current property owner made this renovation in hopes of preserving the home. The southeast corner of the roof is failing and there is evidence of ongoing water damage to that area. Aside from this water damage, the rest of the building appears structurally sound.

*Figure 9. Structure 1 view to the south.*

*Figure 10. Structure 1 view to the west.*

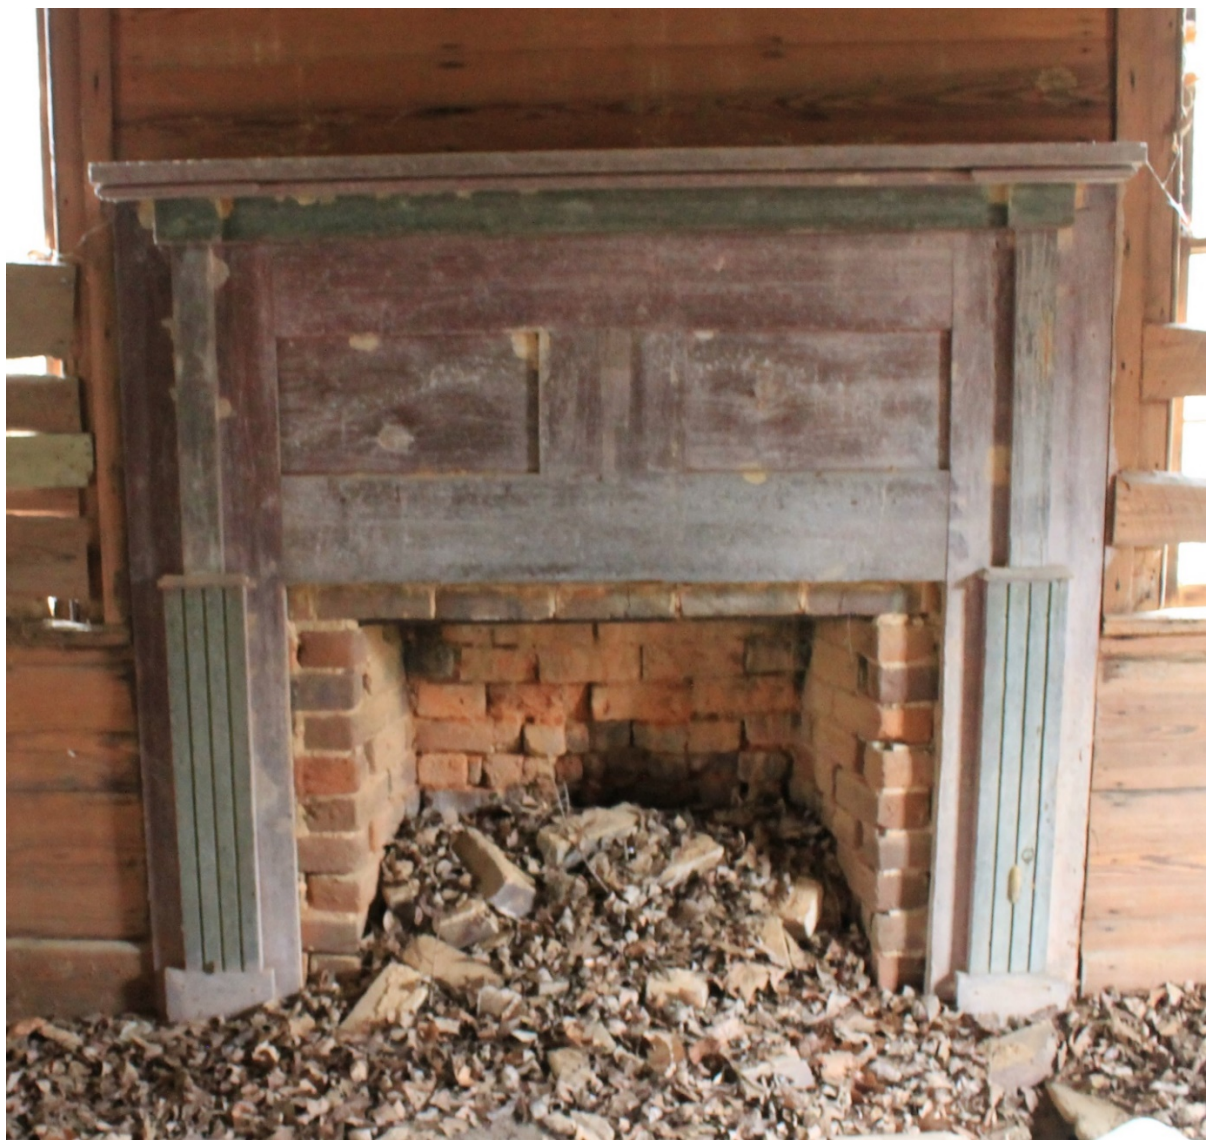
*Figure 11. Northern fireplace of Structure 1.*

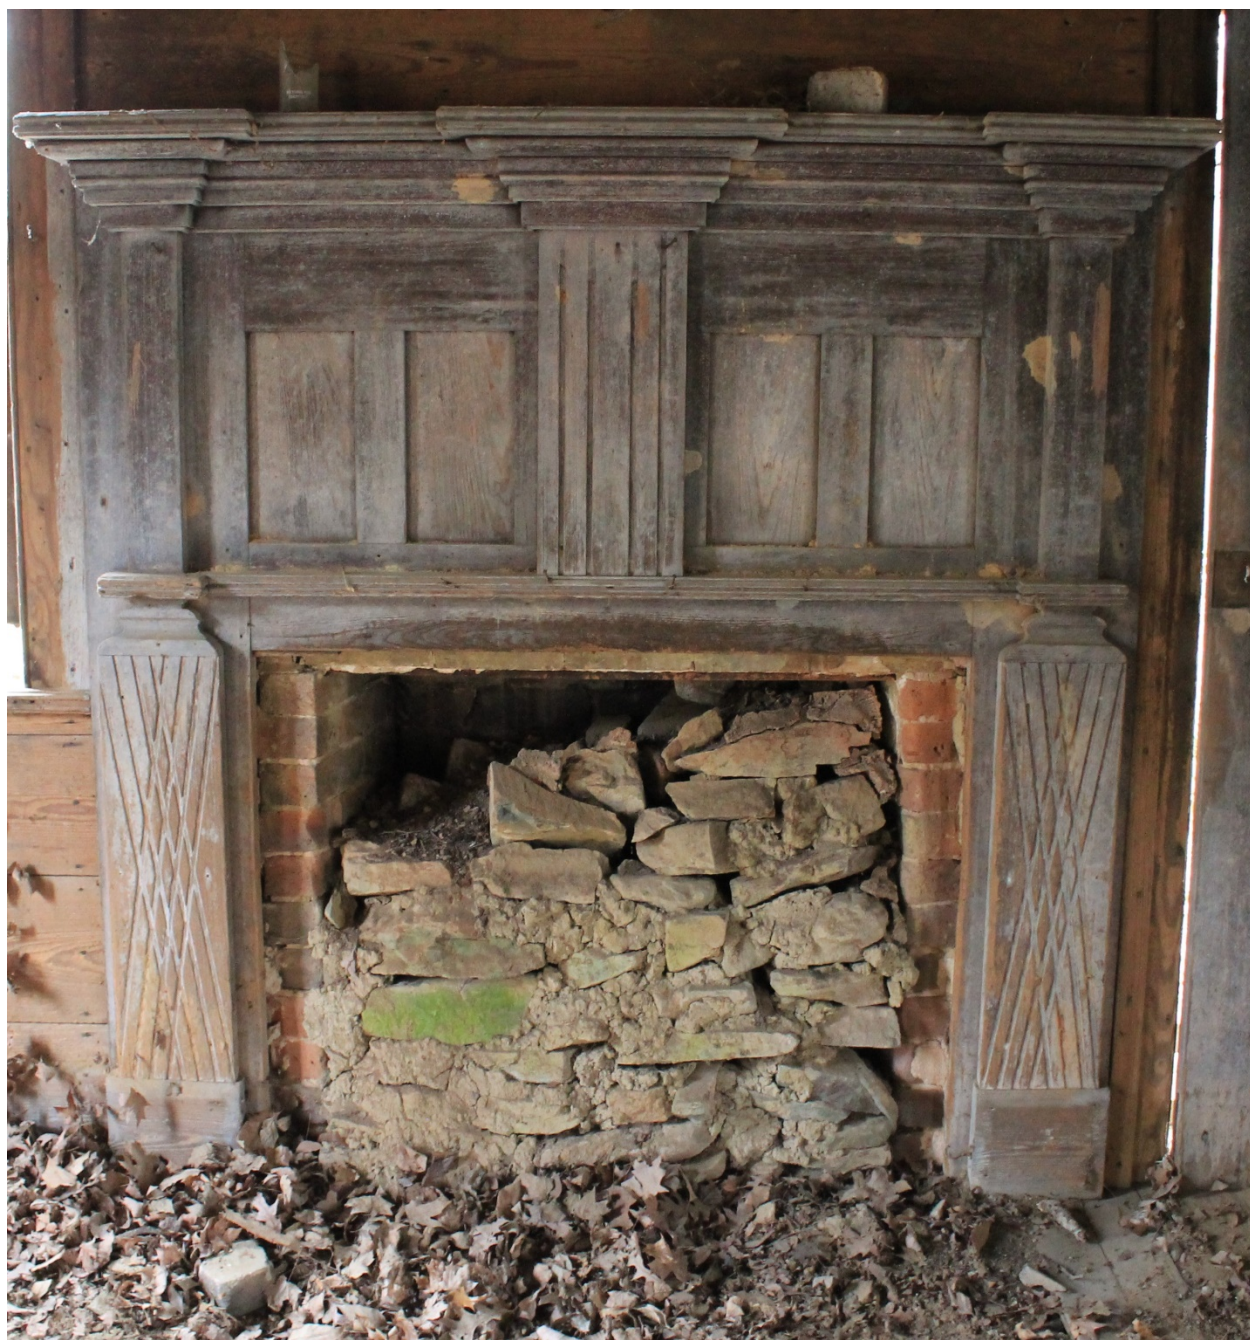
*Figure 12. Southern fireplace of Structure 1.*

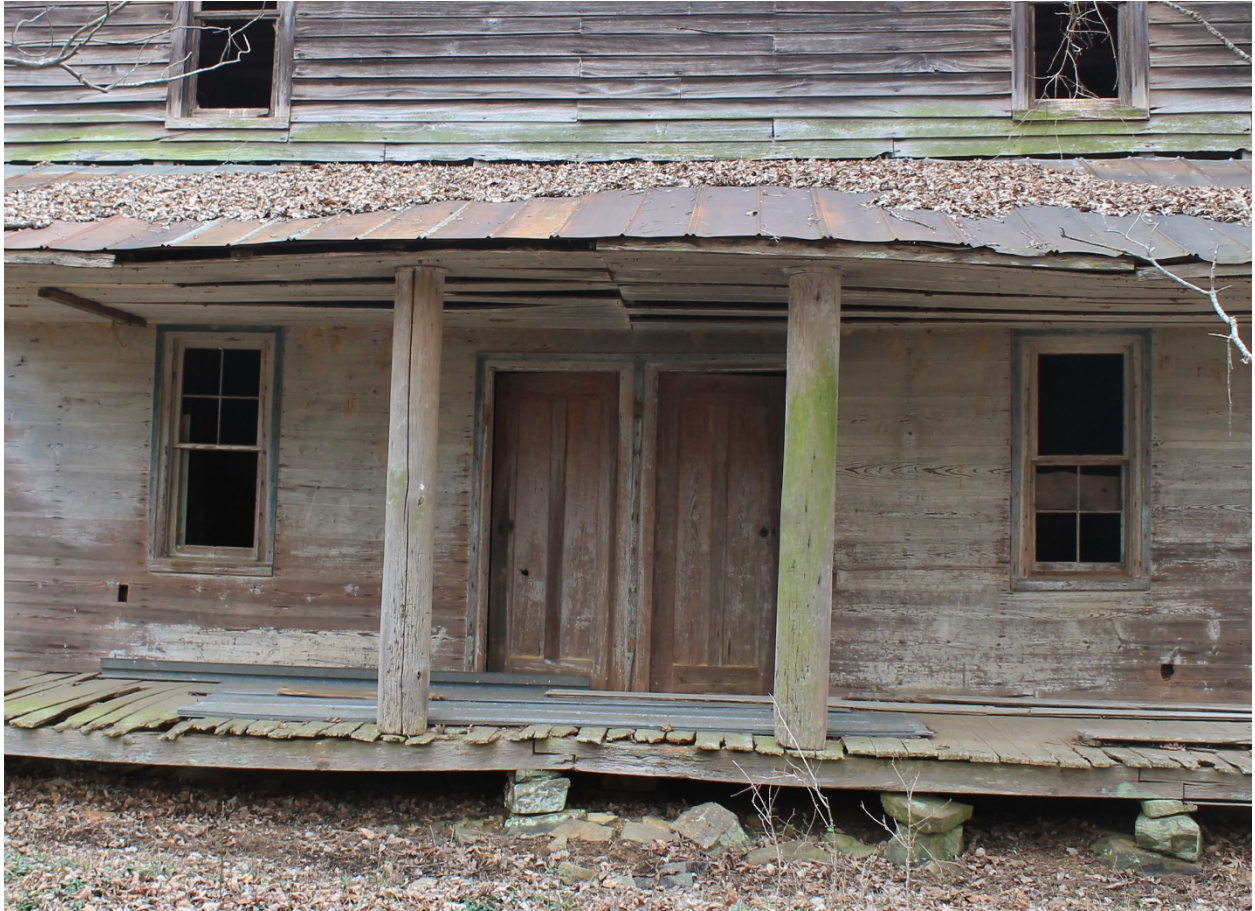
The front of the house is accessed from the porch and has a double-door entry seen in Figure 13. The doors are separate and not part of the same framing. Many explanations exist in the present community for this type of construction. One such suggestion is superstition, this meaning that to enter and exit through the same door was bad luck, necessitating the need for a second door. Another suggestion is that this mode of construction was a popular method employed by the Pennsylvania Dutch (Pennsylvania Historical and Museum Commission). Adding to the above suggestion is a more practical thought. During the early nineteenth-century, the use of an entrance hallway in Pennsylvania Dutch construction began to be abandoned (Kauffman 1954). According to Kauffman, the construction of a second entrance door was used to lessen foot traffic through each room (1954). In addition to the previous explanations, the addition of the second door may have been aesthetic in nature. If a single interior wall was placed in the middle of the house, as at the Fred Graves site, the front door would need to be placed somewhere other than the center of the home to avoid weakening the one interior support

*Figure 13. Structure 1 view to the southeast.*

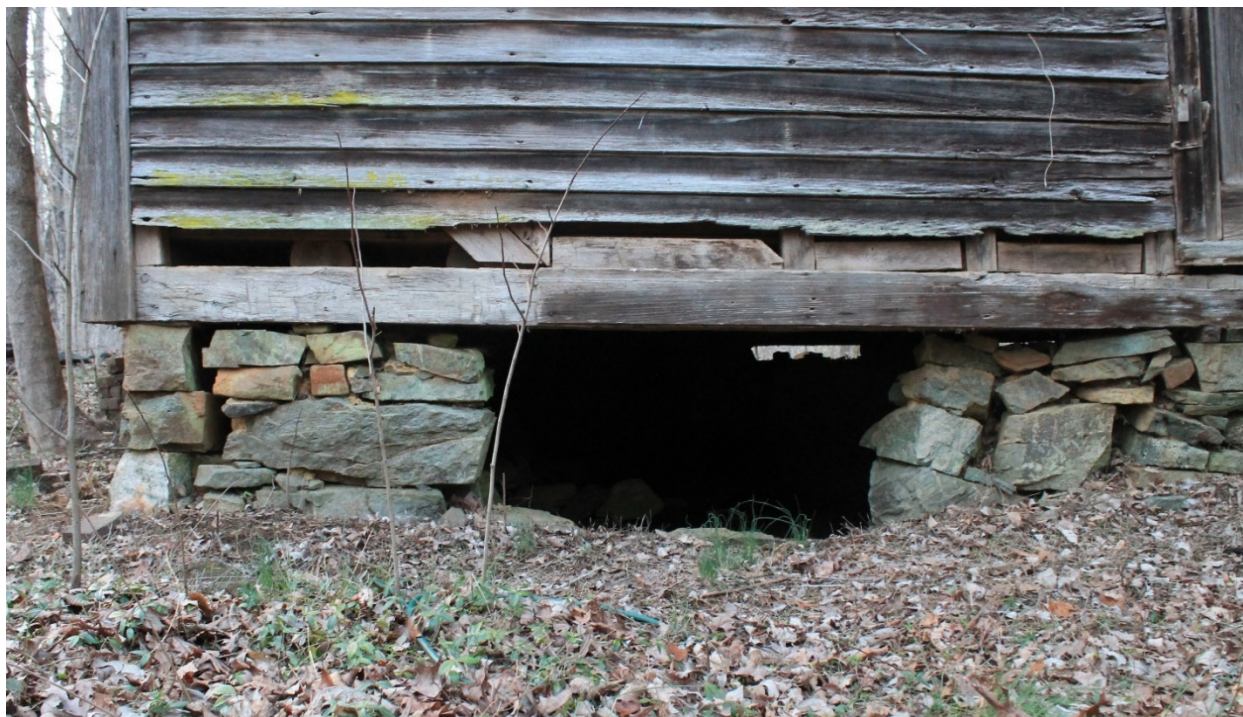
A unique feature of this dwelling is the presence of a possible cellar underneath the lower southern room. From the southwest side of the home, there is a large opening between columns of the stone foundation that can be seen in Figure 14. A circular depression 15 feet (4.57 meters) in diameter, shown in Figure 15, is centered almost below the room. The depression has never been observed free of water. The depth is unknown but is at least 4 feet (1.21 meters) deep based on an attempt to find its depth. The edges of the pit are extremely sharp and no evidence of erosion has been observed over the last 12 years. The ground under the northern room is hard packed and without water. These two sides of the home are separated by wood beams under the home.

*Figure 14. Structure 1 view to the northeast. Close-up of southern foundation corner.*

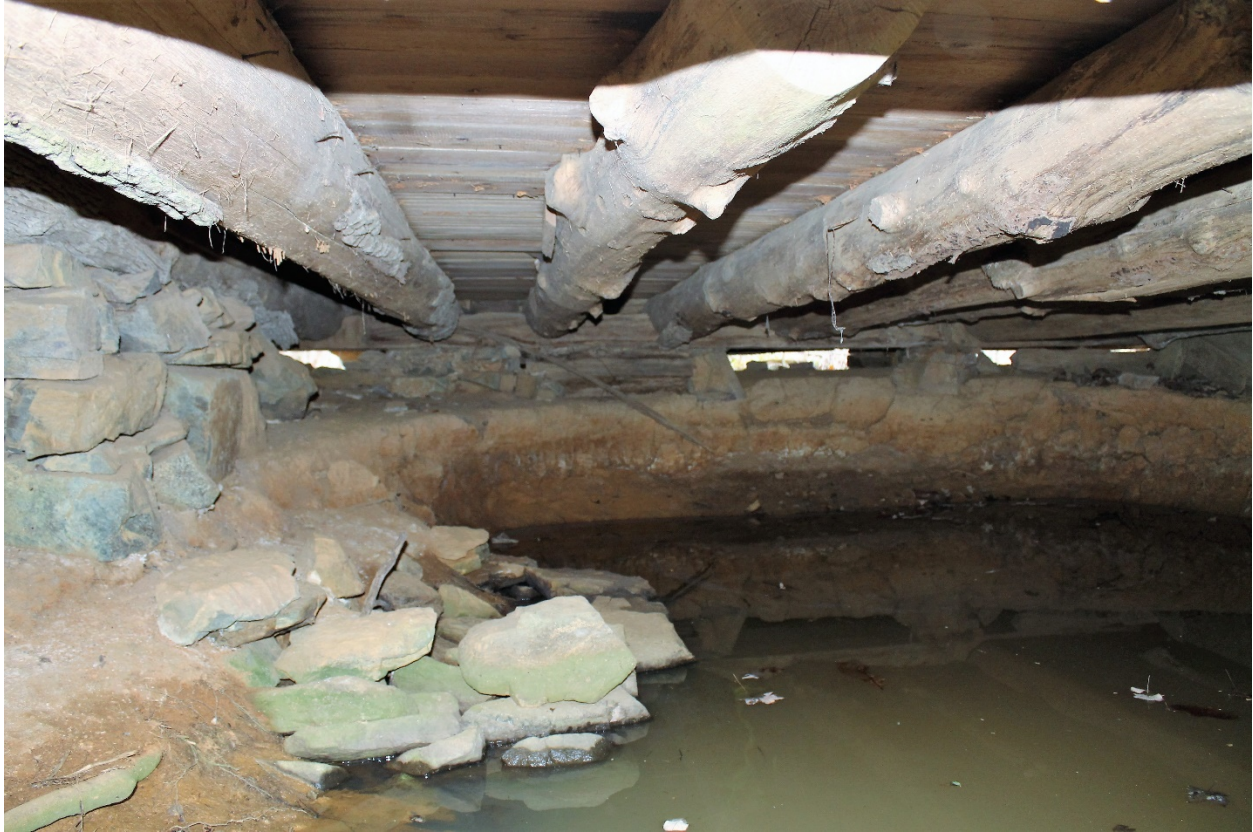
*Figure 15. Structure 1 view underneath the southern room.*

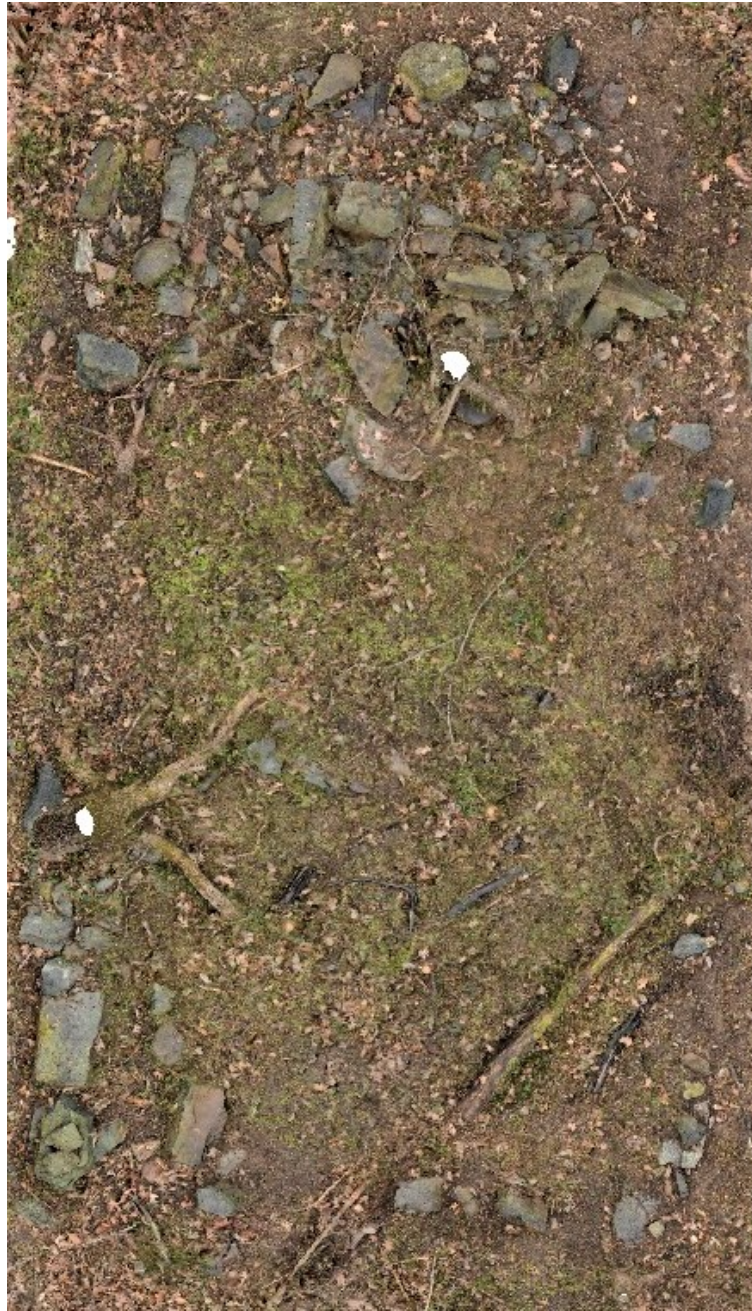
Figure 16 shows the outline of the foundation stones. The remnants of the chimney are at the top of the photo. The line of stones indicating a filled in cellar pit or room partition can be

*Figure 16. Structure 2 vertical view. Northwest (chimney ruins) at top. Image from 3D model.*

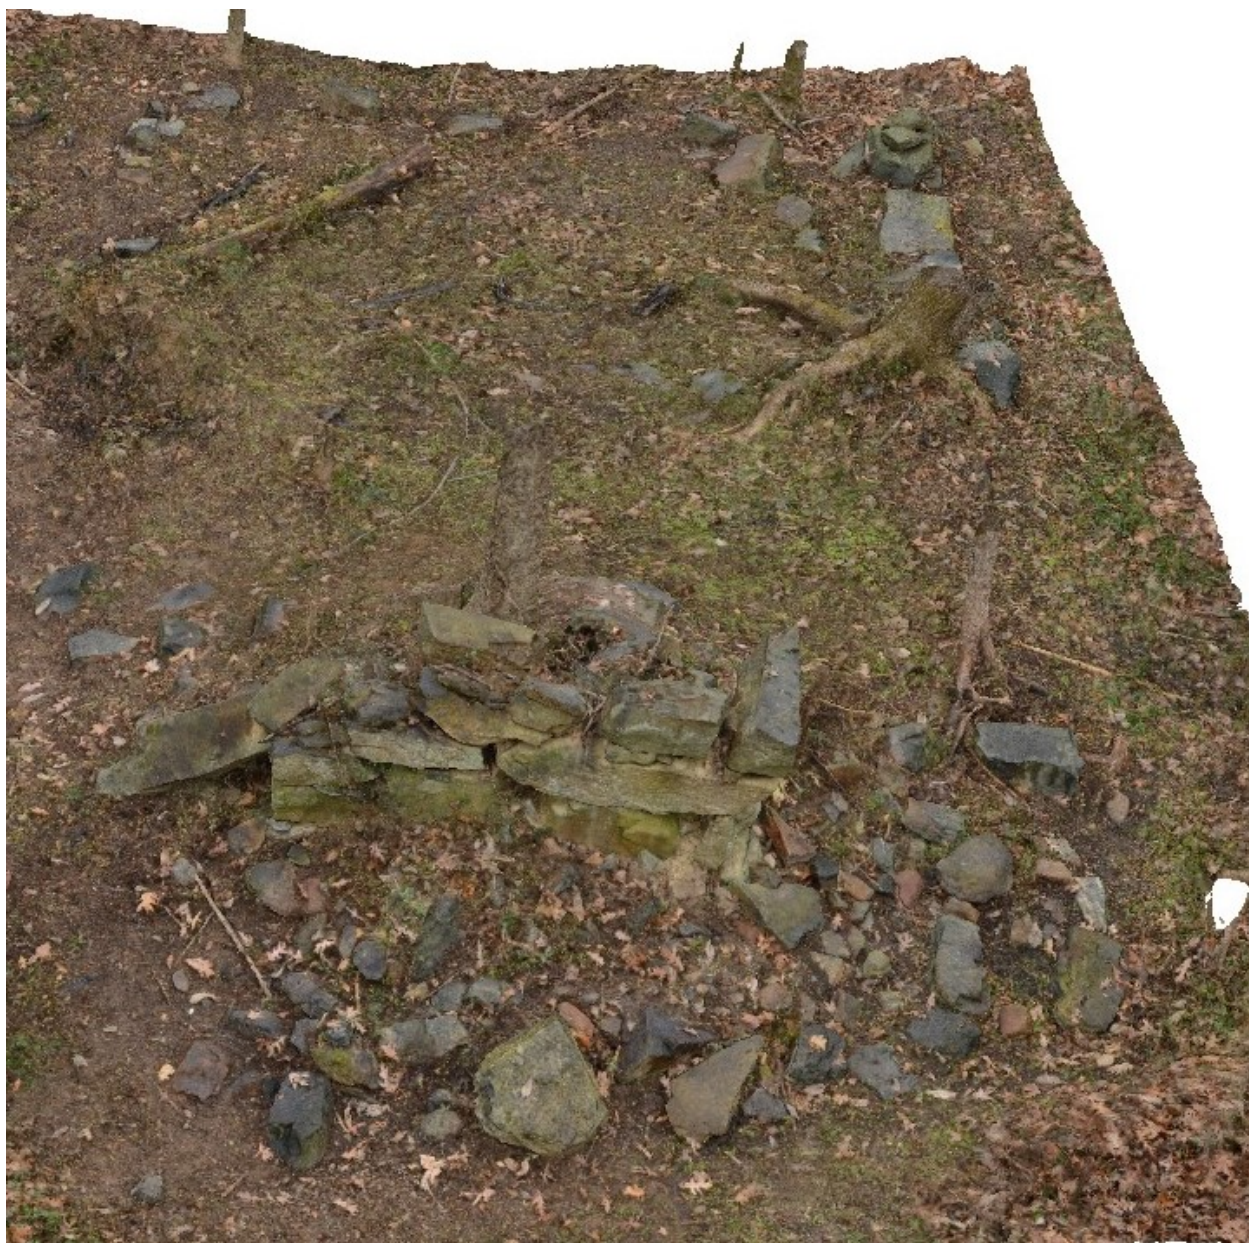
seen in this view near the midpoint of the photo. Figure 17 is an oblique view of Structure 2 with chimney ruins in the foreground. Figure 18 is a photo of the chimney ruins.

*Figure 17. Structure 2 oblique view to the southeast. Chimney ruins in foreground. Image from 3D model.*

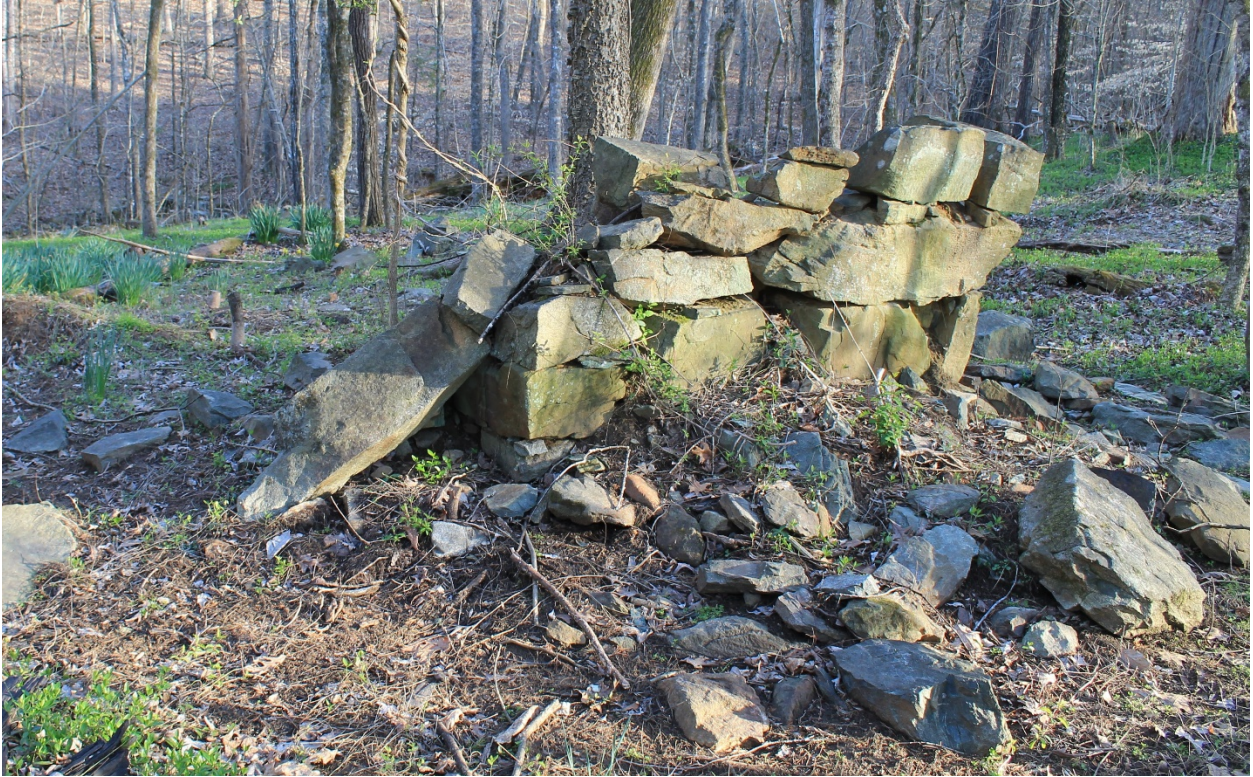
*Figure 18. Structure 2 chimney ruins view to the southeast.*

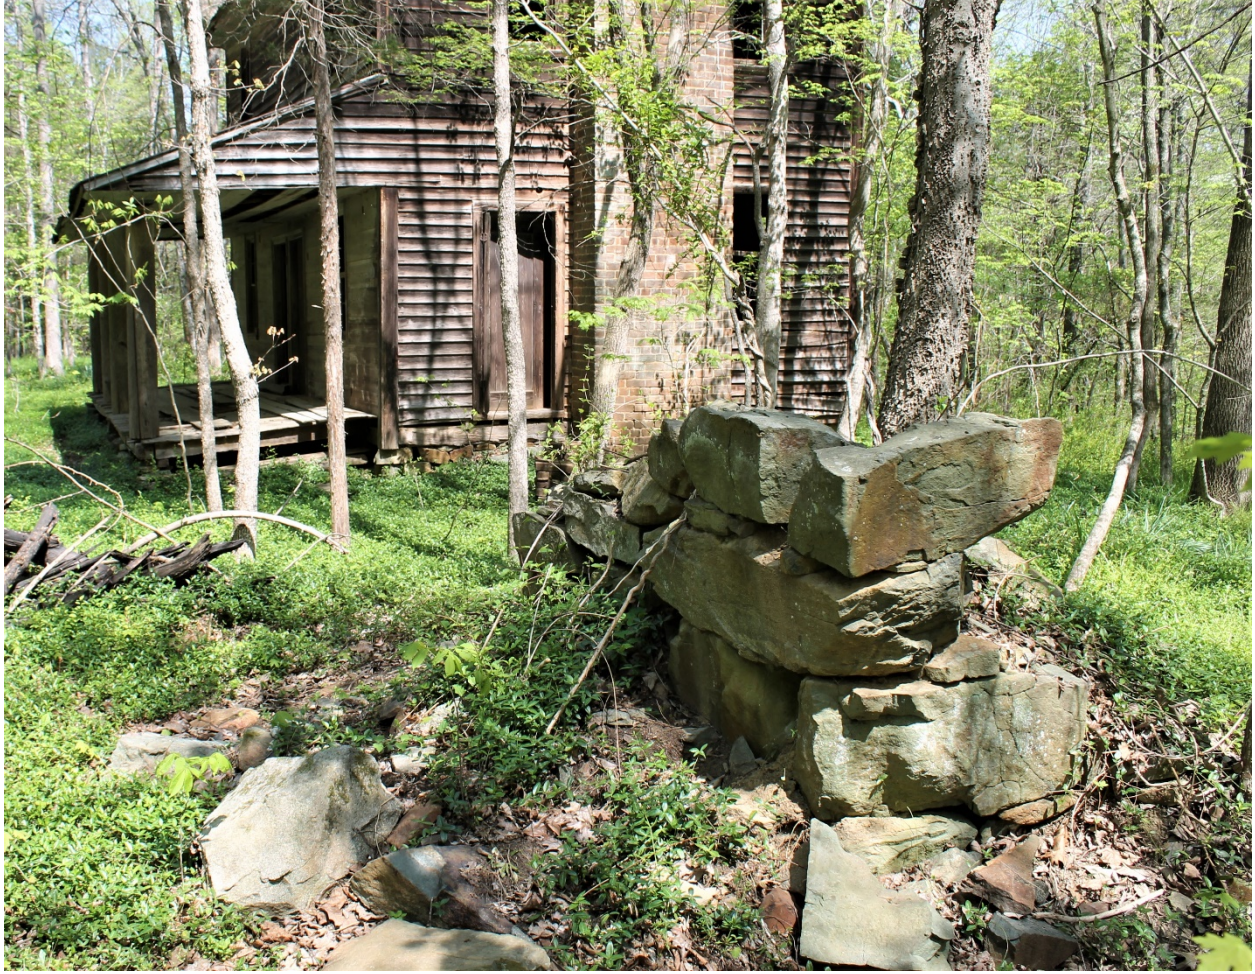
Figure 19 (below) shows Structures 1 and 2. This view is offered to give the reader an understanding of the proximity of these two structures to each other. This ties into the possibility that they were used during some portion of the same time period.

*Figure 19. Structures 1 and 2 view to the northeast showing proximity to one another.*

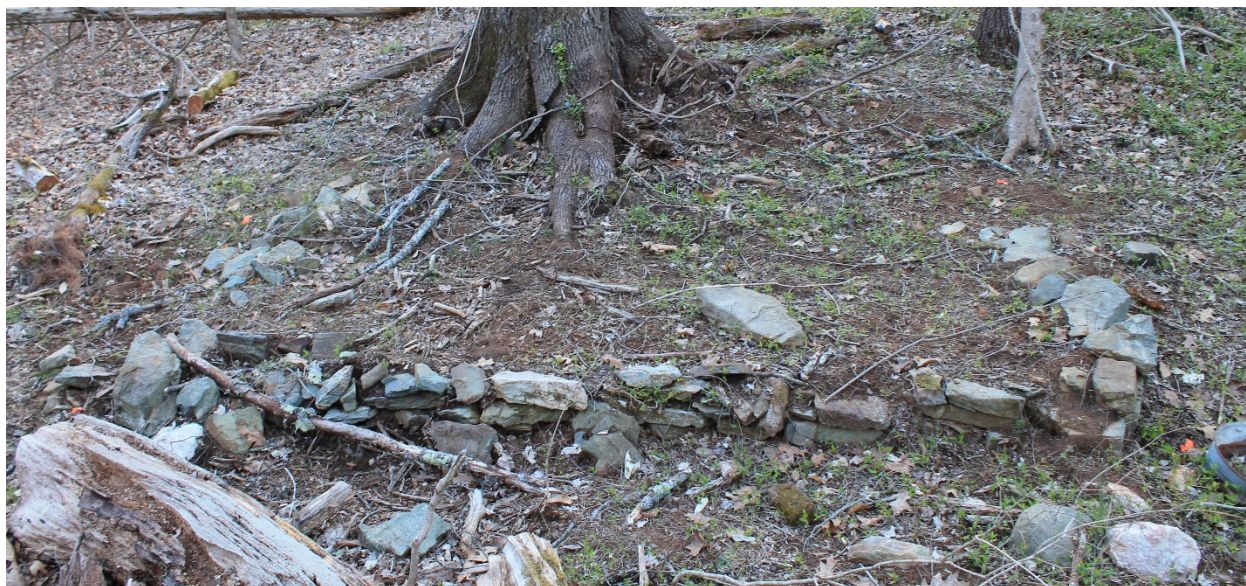
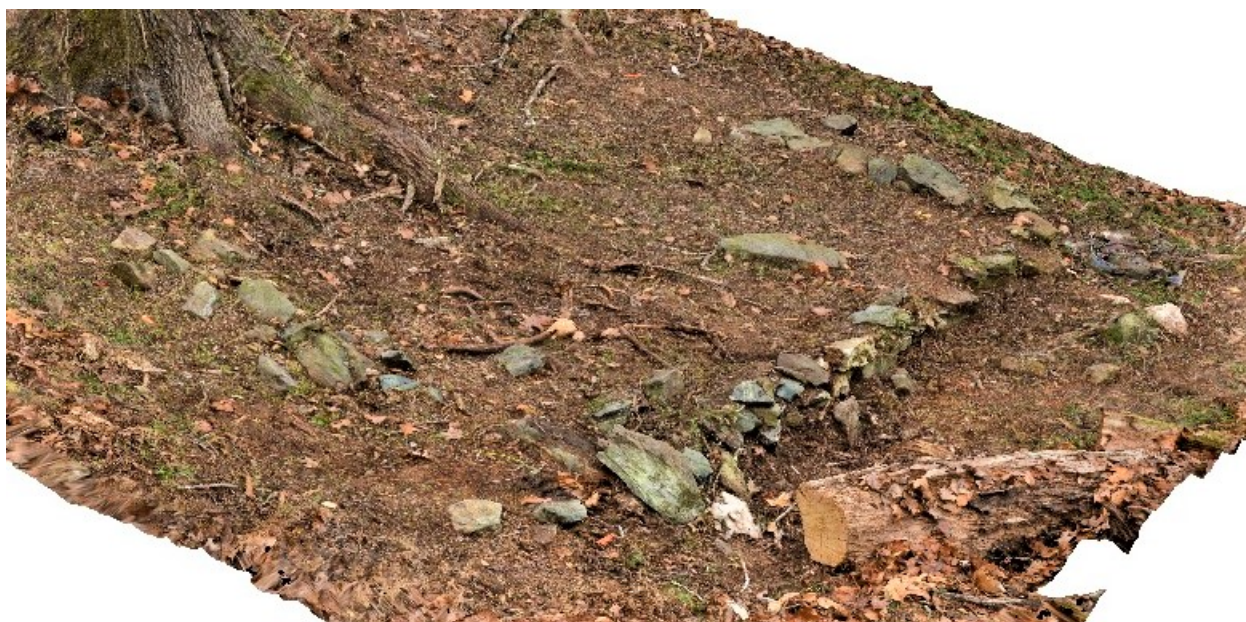
Southeast of the two previous structures is Structure 3. This structure is indicated by a rectangular alignment of stones shown in Figure 20 and Figure 21. The north, west, and east sides of the foundation are visible. The foundation on the south side is missing. The south side, based on the endpoints of the east and west foundations, terminated at a small but sharp rise in ground elevation. The north foundation wall is approximately 3.1 inches (8 centimeters) above ground level and may have included a walkway of laid stones.

*Figure 20. Structure 3 oblique view to the south.*

*Figure 21. Structure 3 oblique view to the northwest. Image from 3D model.*

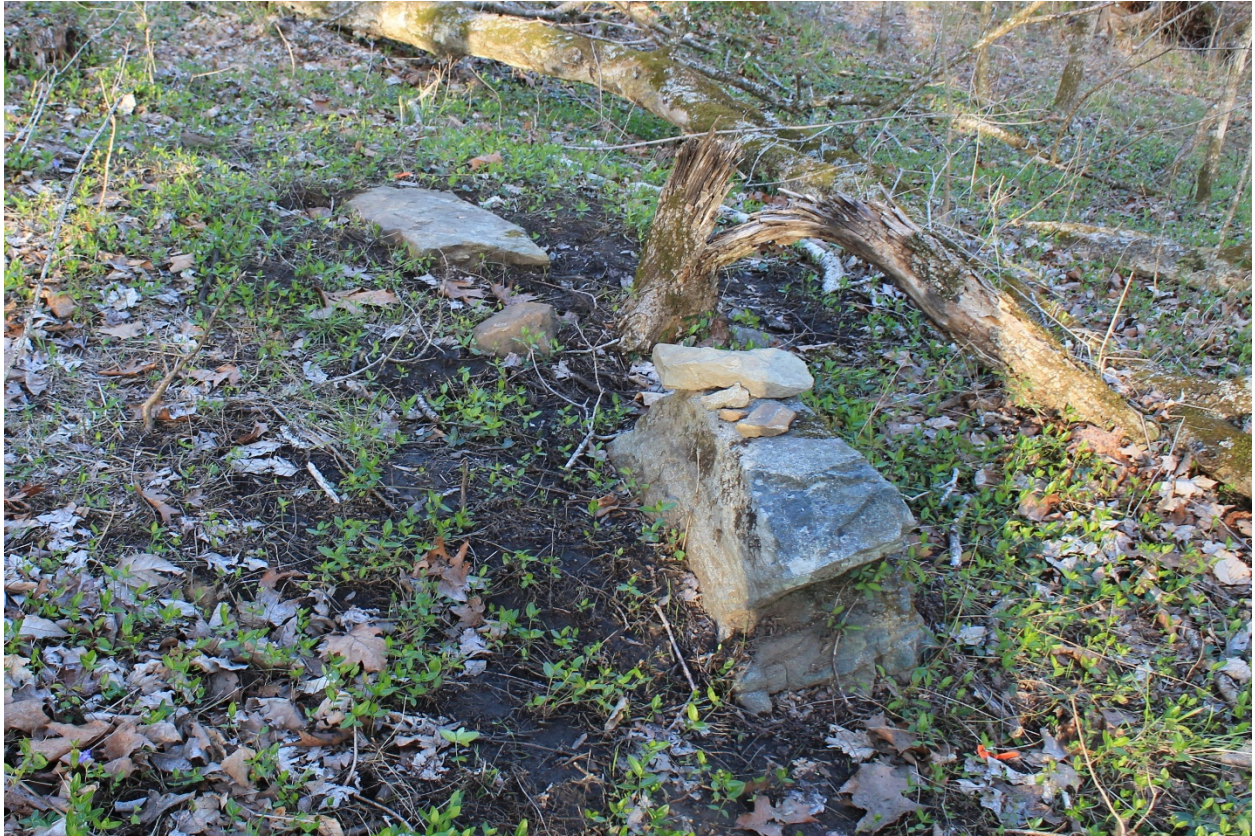
Just north of Structure 3 is a short line of stones 6.5 feet (2 meters) in length. The alignment appears to have been manmade rather than naturally occurring. The stones are laid end-to-end and form a straight line. They may not have been noticed if not for a random shovel test dug before the stones were visible. The author conducted two shovel tests to see how deep the topsoil was before reaching the red clay subsoil. The test near the dwelling struck clay at 5.9 inches (15 centimeters). When a test was performed at Structure 4, a small portion of a soapstone bowl, a fragment of lead glazed earthenware, and pieces of charred brick were recovered. These were found somewhere between surface level and 9.8 inches (25 centimeters) below surface. Black crumbly topsoil occupied the first 9.8 inches (25 centimeters) here. After that depth, red clay was reached. This discrepancy in subsoil depth was curious. Following this shovel test, leaf blowing revealed the line of laid stones shown in Figure 22. No other foundation or corner stones could be located in association with Structure 4.

*Figure 22. Structure 4 view to the northeast.*
