SURVEY AND MAPPING OF THE FRED GRAVES SITE:  
LAYING THE GROUNDWORK FOR UNDERSTANDING A RURAL NON-PLANTATION-  
BASED SOUTHERN COMMUNITY

Honors Thesis  
Curriculum in Archaeology  
University of North Carolina at Chapel Hill

2018

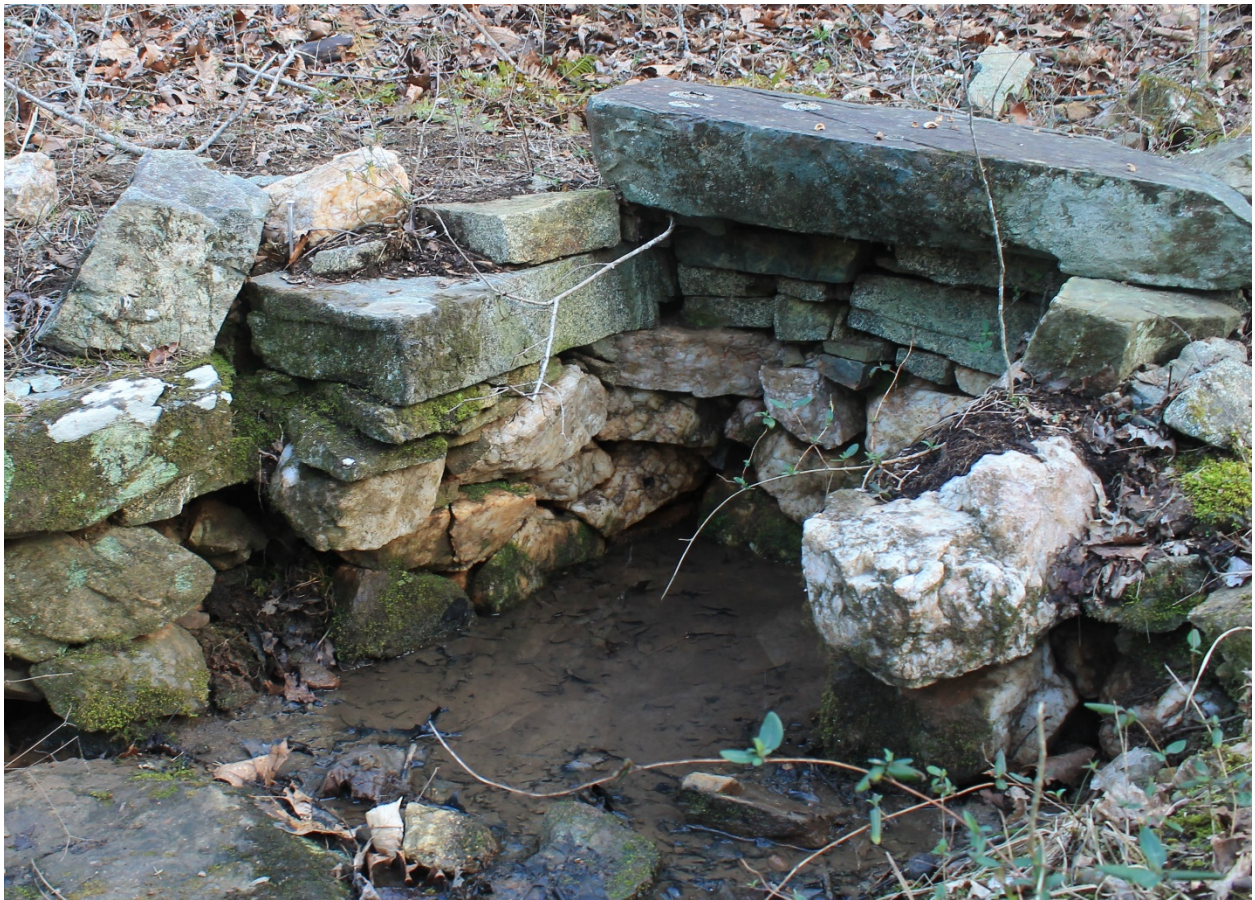
East of all the other previously discussed structures and features, across the stream, is Structure 5. This is a spring that would have provided fresh water at the site. The spring box, seen in Figure 23, does not look as if it has been altered since its last use. None of its stones appear out of place and it retains its square appearance. It provides only a trickle of water now and is filled with sediment, tree limbs, and years of leaf accumulation. Initially, all that could be seen in this area was the box itself.

*Figure 23. Structure 5 view to the south.*

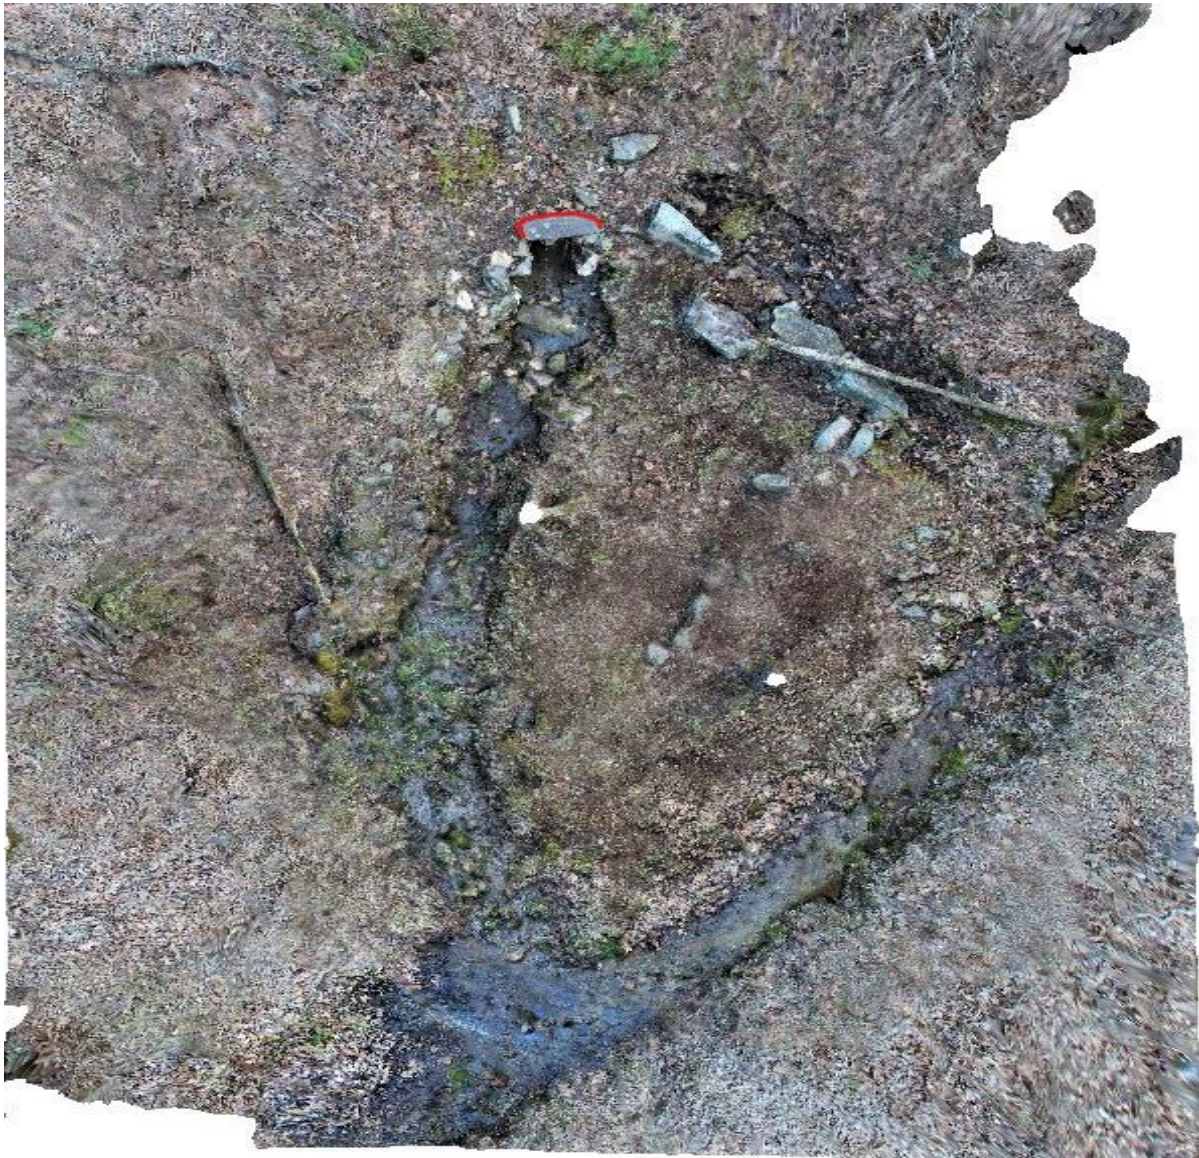
Photogrammetry was used to create a 3D computer model of the spring box. When viewing the original model, not shown here, the remnants of a possible foundation around the box could be seen. Subsequent clearing of surface debris yielded a more complete picture and a second 3D model was created. This model, shown in Figure 24, revealed the clear presence of a line of stones potentially forming a wall foundation.

*Figure 24. Structure 5 vertical view. South at top. Spring box outlined in red. Image from 3D model.*

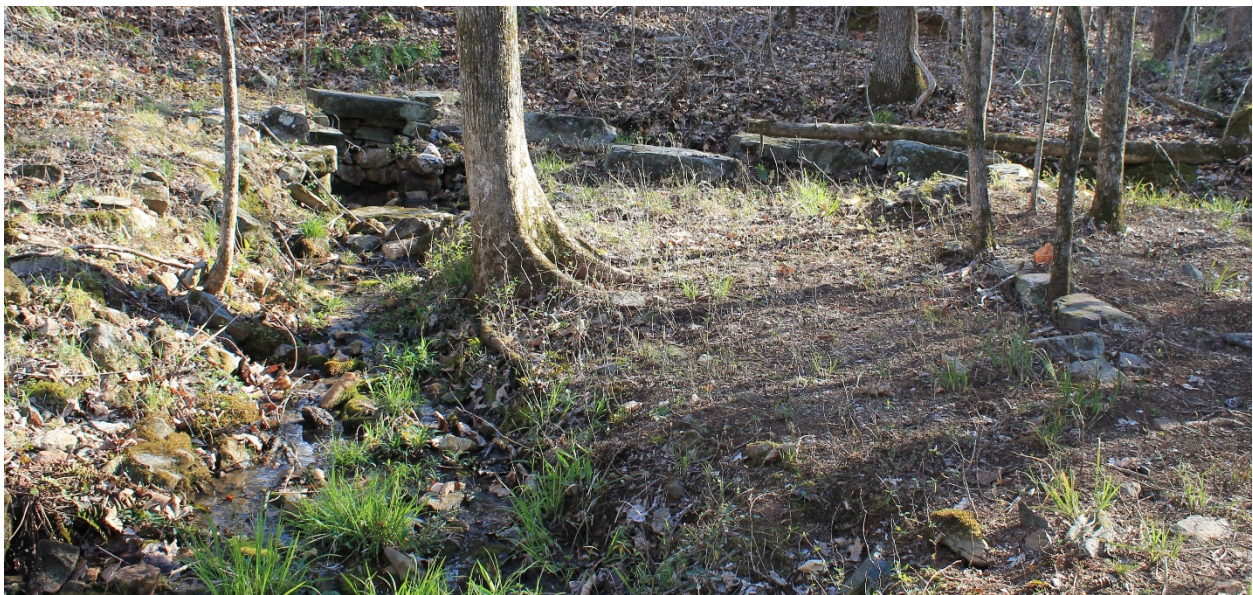
Such a foundation would be expected as a structure would be needed to keep the spring free from debris that might clog it. One might expect to find remnants of food storage items in this area. The bottom of a glass bottle that resembles a milk container, as well as a sherd of lead-glazed earthenware, was found in the water fed by the spring. The only artifacts found on the surface within the foundation were spent ammunition casings of modern munitions. The calibers included .223, 9mm, and 38 special. None of these calibers are commonly used in hunting and were probably the result of target practicing or the random discharge of weapons. Excavation may provide evidence to support this foundation as being an area of cold food storage. Figure 25 is a view of Structure 5 with the spring box located at the left rear of the photo.

*Figure 25. Structure 5 view to the south.*

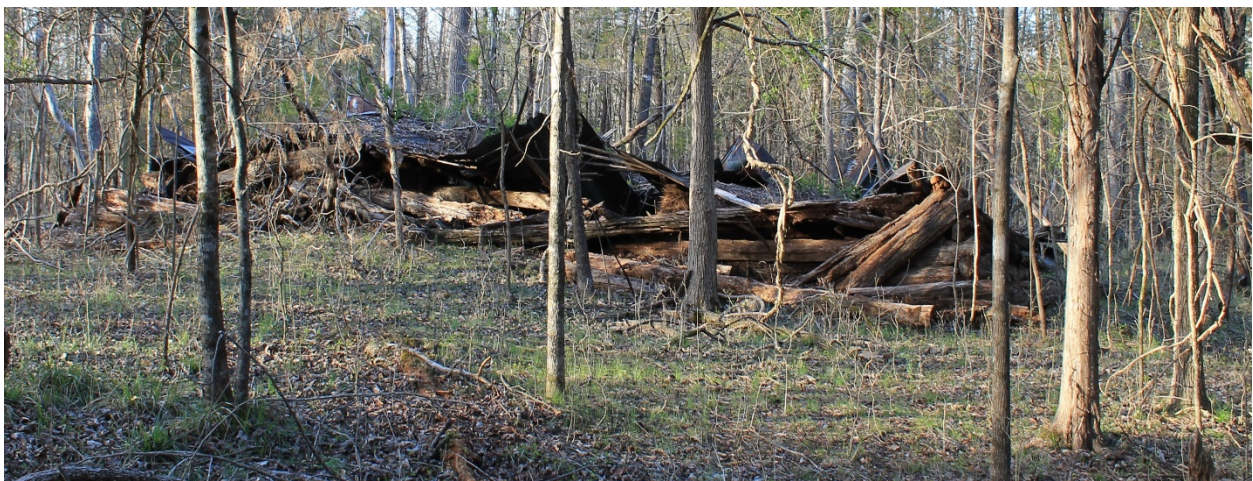
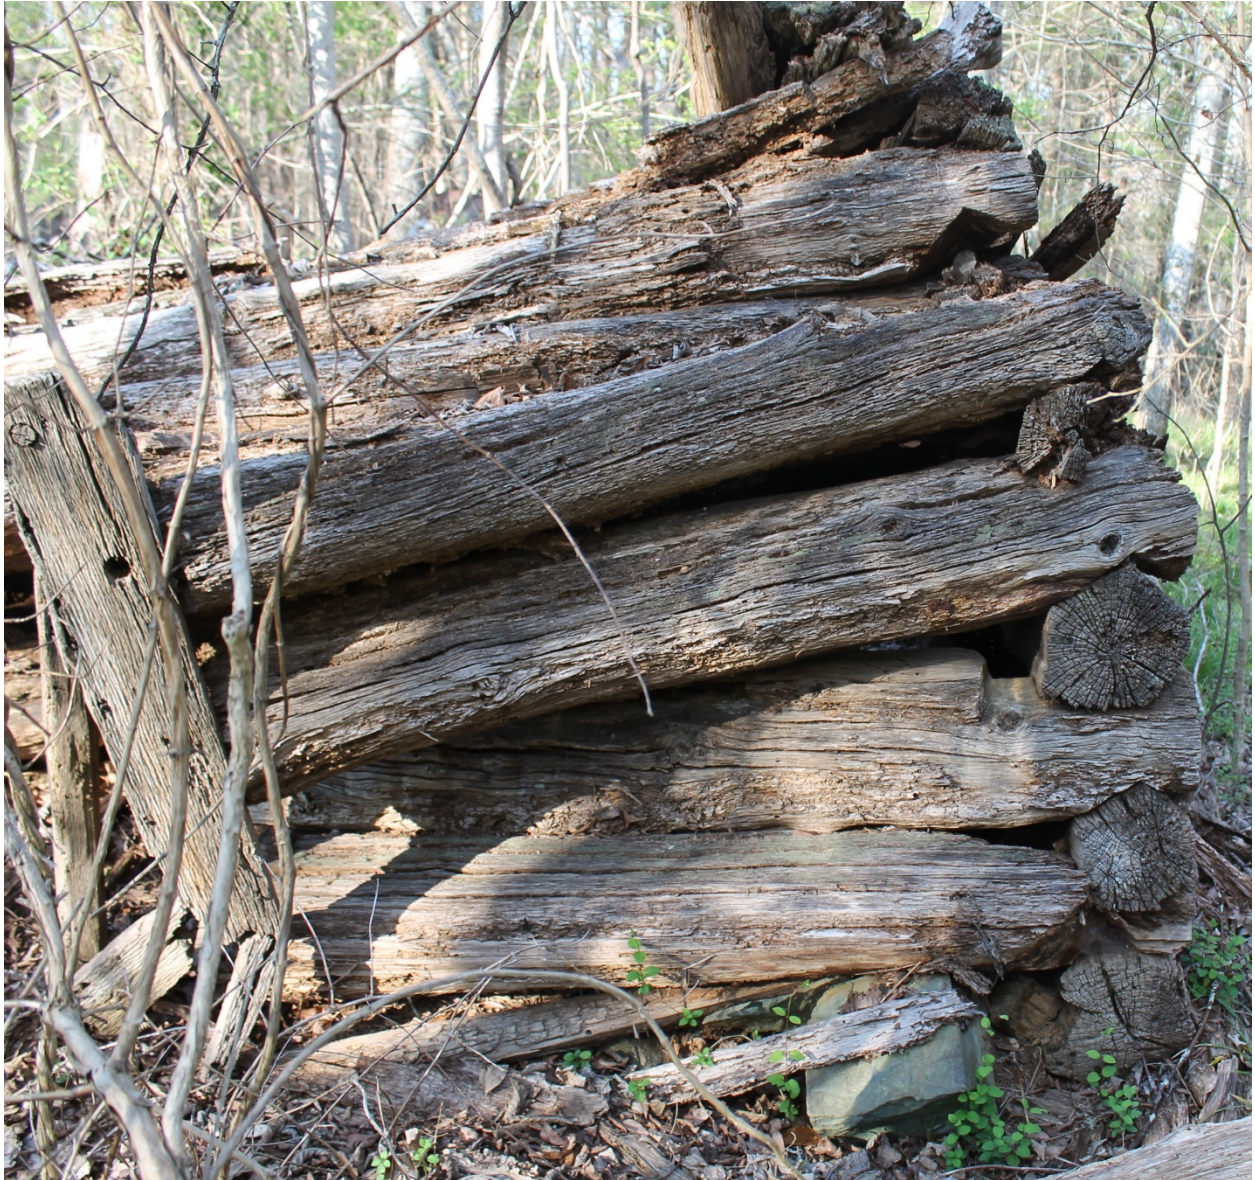
Structure 6, shown in Figure 27, is the northernmost structure within Area B. It is the fallen remains of a cribbed-log barn. The corners of the barn were built using a notched log and stacking method. Other areas of the structure were built with peg-and-hole methods as well as machine-cut nails for fastening. Figure 28 shows the peg-and-hole method of construction, and was taken prior to the further collapse shown in Figure 27. As with the dwelling, wire nails were only found in what appeared to be repair work or added features. The property owner was able to recall its appearance before its destruction, and noted it had been enclosed on three sides by a lean-to. Foundation stones used to support the lean-to are visible on three sides of the barn. It appears the barn continued to be used until the mid-twentieth-century to store hay and other equipment. Older equipment is still present just outside the interior footprint of the structure but within the lean-to foundation stones. Those foundation stones encircle the barn on three sides.

*Figure 27. Structure 6 view to the north.*

*Figure 28. Structure 6. View to the north.*

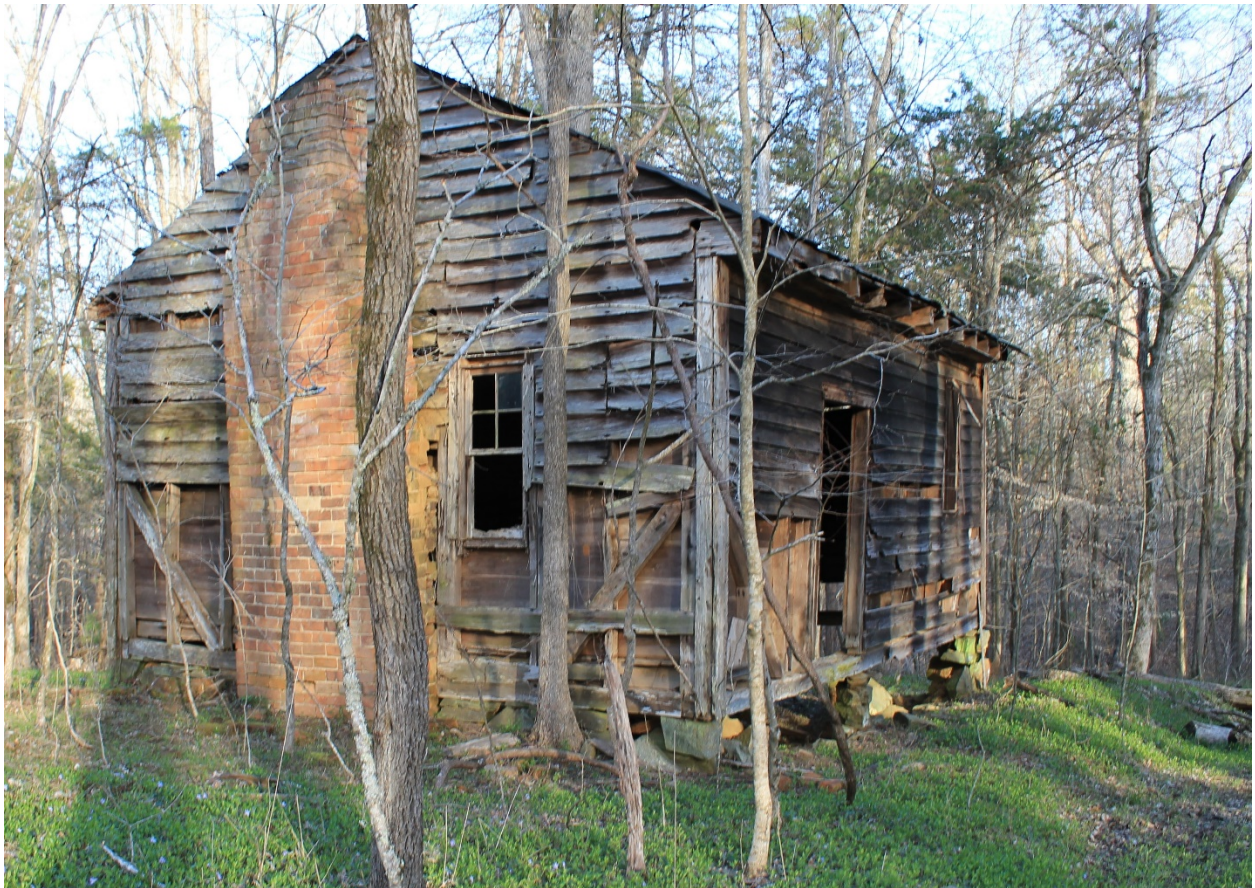
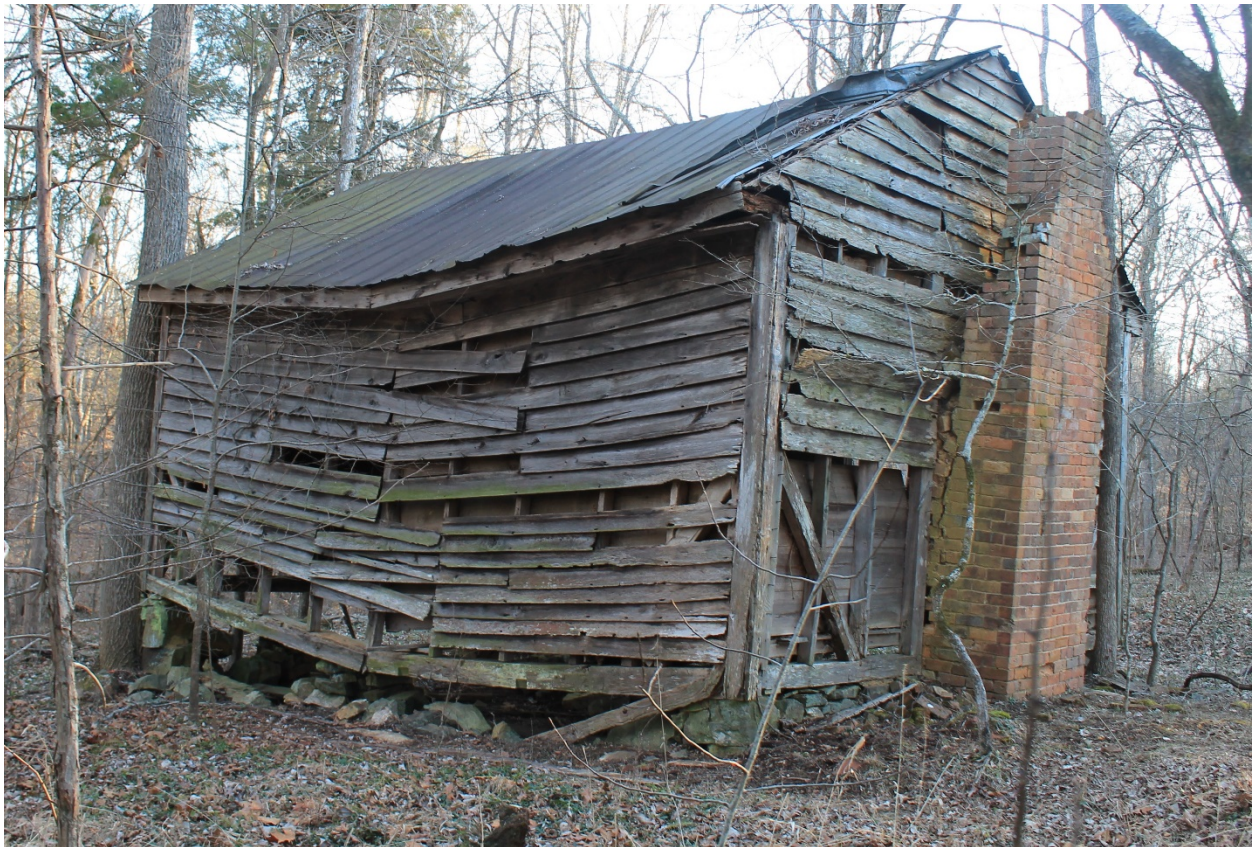
Structure 7, like Structure 6, sits north of the roadbed that splits Area A, from Area B. It is unique in that, like Structure 1, it is still standing. Structure 7 is shown in Figures 29 and 30 below. Its condition is much worse than the dwelling. The majority of its floor has been

*Figure 29. Structure 7 view to the east. Photo taken from the roadbed that divides Area A and Area B.*

*Figure 30. Structure 7 view to the south.*

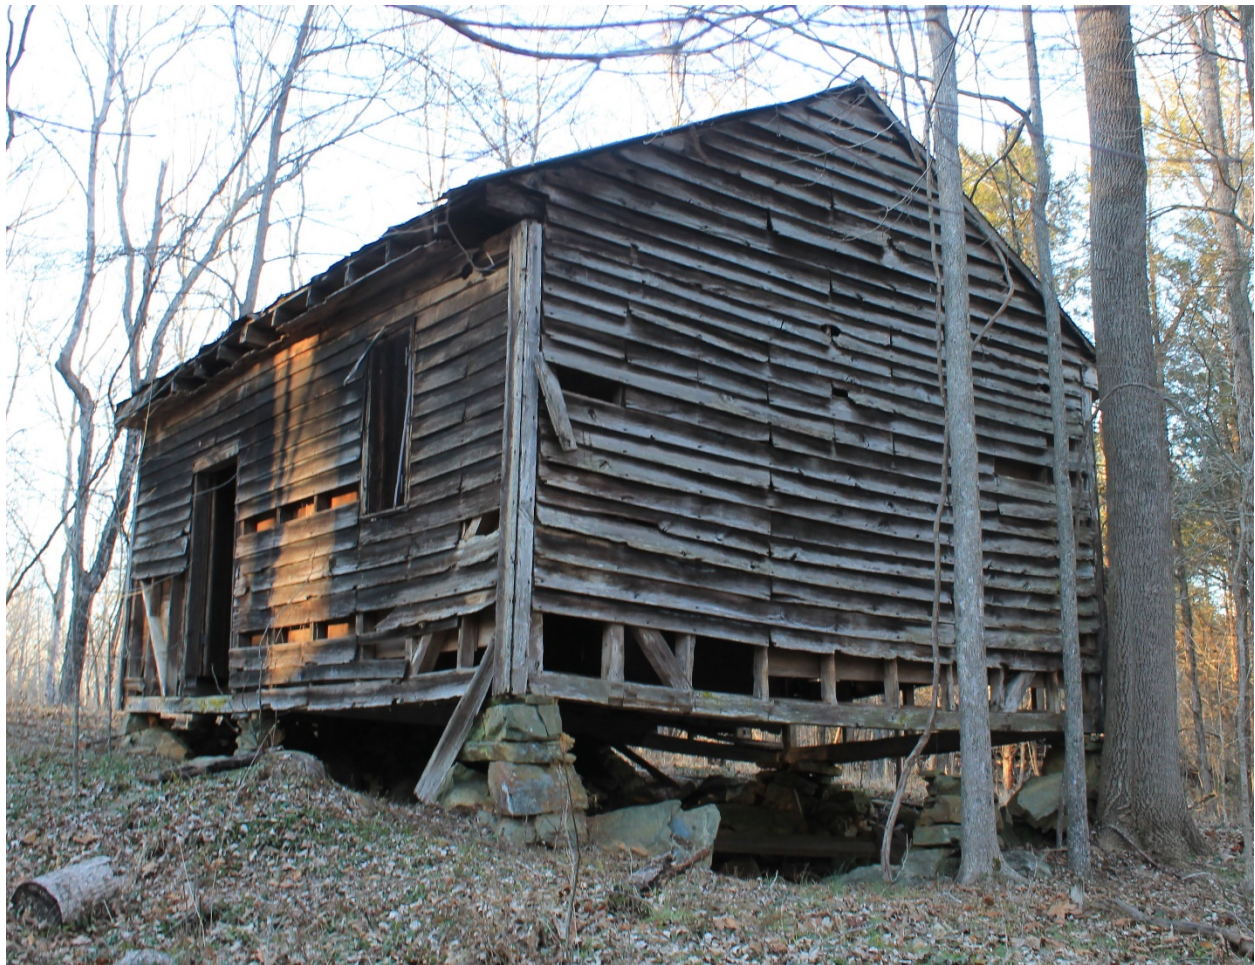
floor and corner support beams were assembled using peg construction. The remainder of the building used machine-cut square nails. This structure may have had a cellar. There is an area below the level of the floor that extends 4.6 feet (1.4 meters) to the ground. It is admitted that this could be the result of erosion, but the variance in foundation height make the presence of a cellar likely. The northwestern end of the structure is 1.1 feet (34 centimeters) above ground. The rear southeastern end has a height of 2.88 feet (88 centimeters) which would allow for fairly easy access to goods stored there (Figure 31). The absence of the floor and cross beams may have removed evidence that would support the existence of a cellar.

*Figure 31. Structure 7 view to the north. Opening to possible cellar visible.*

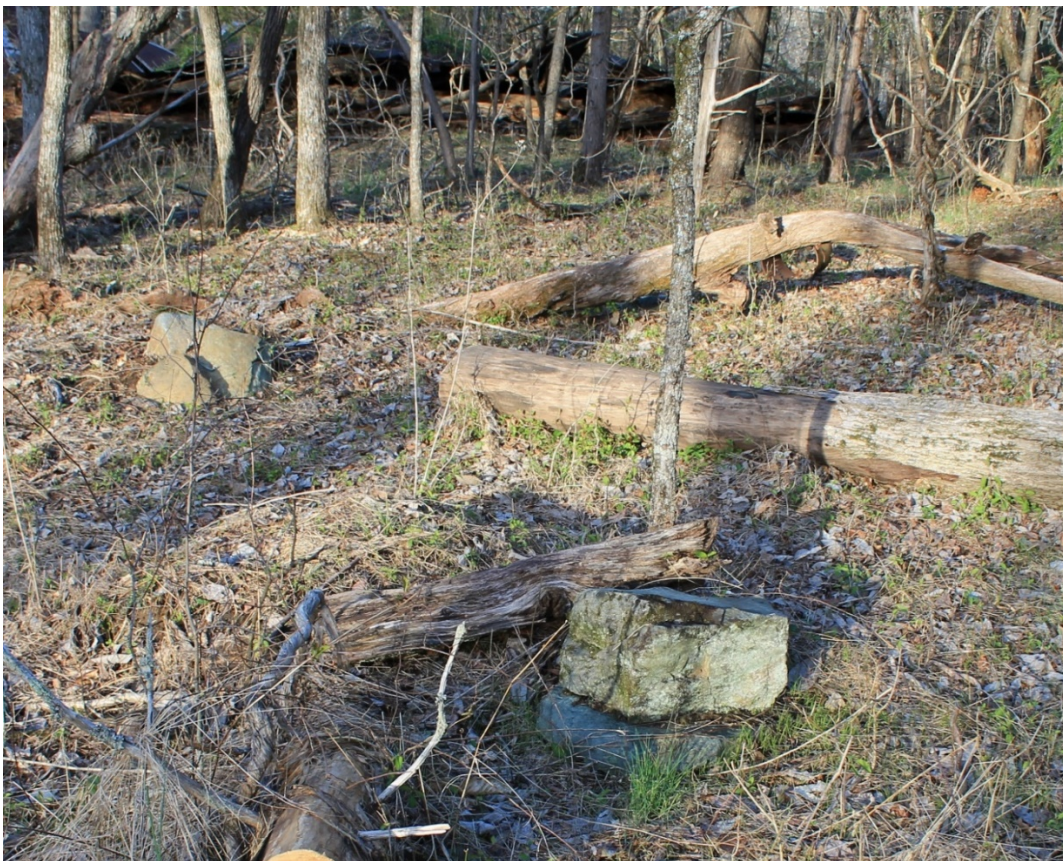
Structure 8 was not discovered until after the completion of field work. This feature is a line formed by three sets of stone piers located northwest of Structures 6 and 7 and parallel to the roadbed skirting the west side of site. The piers form a line 32 feet (9.7 meters) long parallel with the northwest roadbed. Two of the piers are shown in Figure 32 below. These stones are very close to the road and no sides or other corners were seen. Further evidence of this being a structure was the presence of a piece of hand-hewn lumber about 3.2 feet (1 meter) long, wedged beside one of the stones. This piece of lumber had square machine cut nails driven through it.

*Figure 32. Structure 8 (two of the piers) view to the northeast. Ruins of Structure 6 visible in background.*

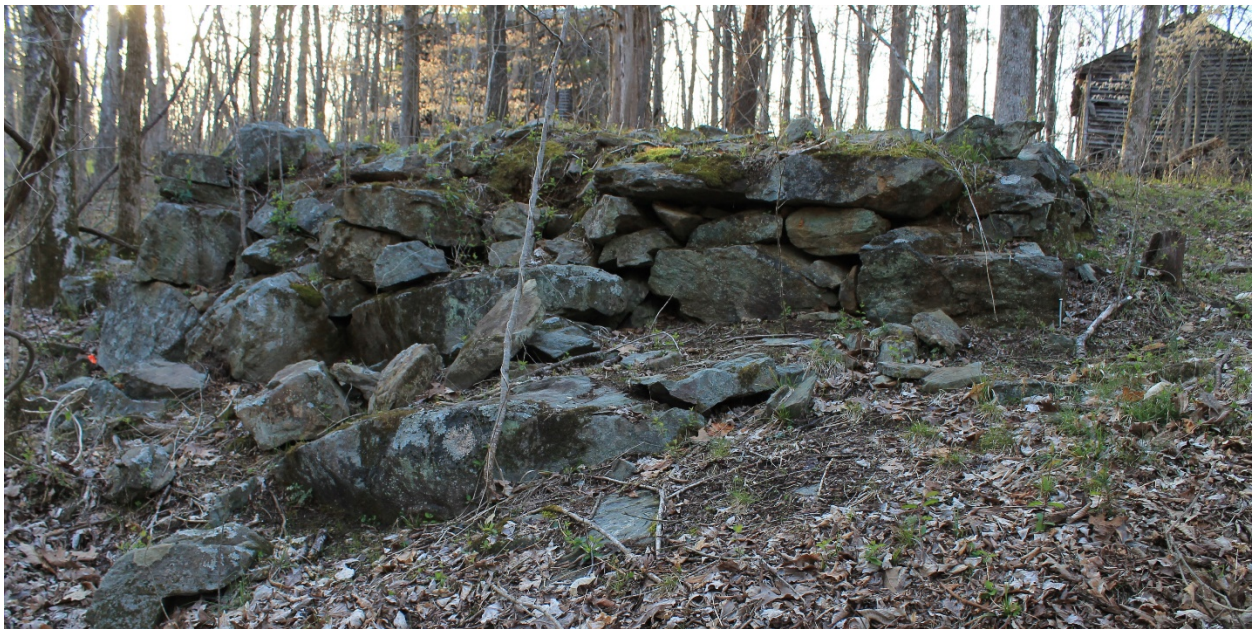
Structure 9 is located directly east of Structure 7 and is between it and the stream. This configuration can be seen in Figure 33. Structure 9 represents the ruins of a stone foundation. The northwest side of the foundation sits at ground level; the southeast side of the foundation is much higher due to its location on the slope towards the stream. It has an overall square shape that is 16 feet by 16 feet (4.87 meters by 4.87 meters). The property owner was told by his uncle that this was the site of a blacksmith's shop. No surface artifacts were recovered from this structure to support nor refute that interpretation. When looking at orthographic photos, features become visible that delineate this structure's overall square shape. In the west corner, a second smaller square is visible within the foundation (Figure 34).

*Figure 33. Structure 9 view to the northwest. Structure 7 visible background right.*

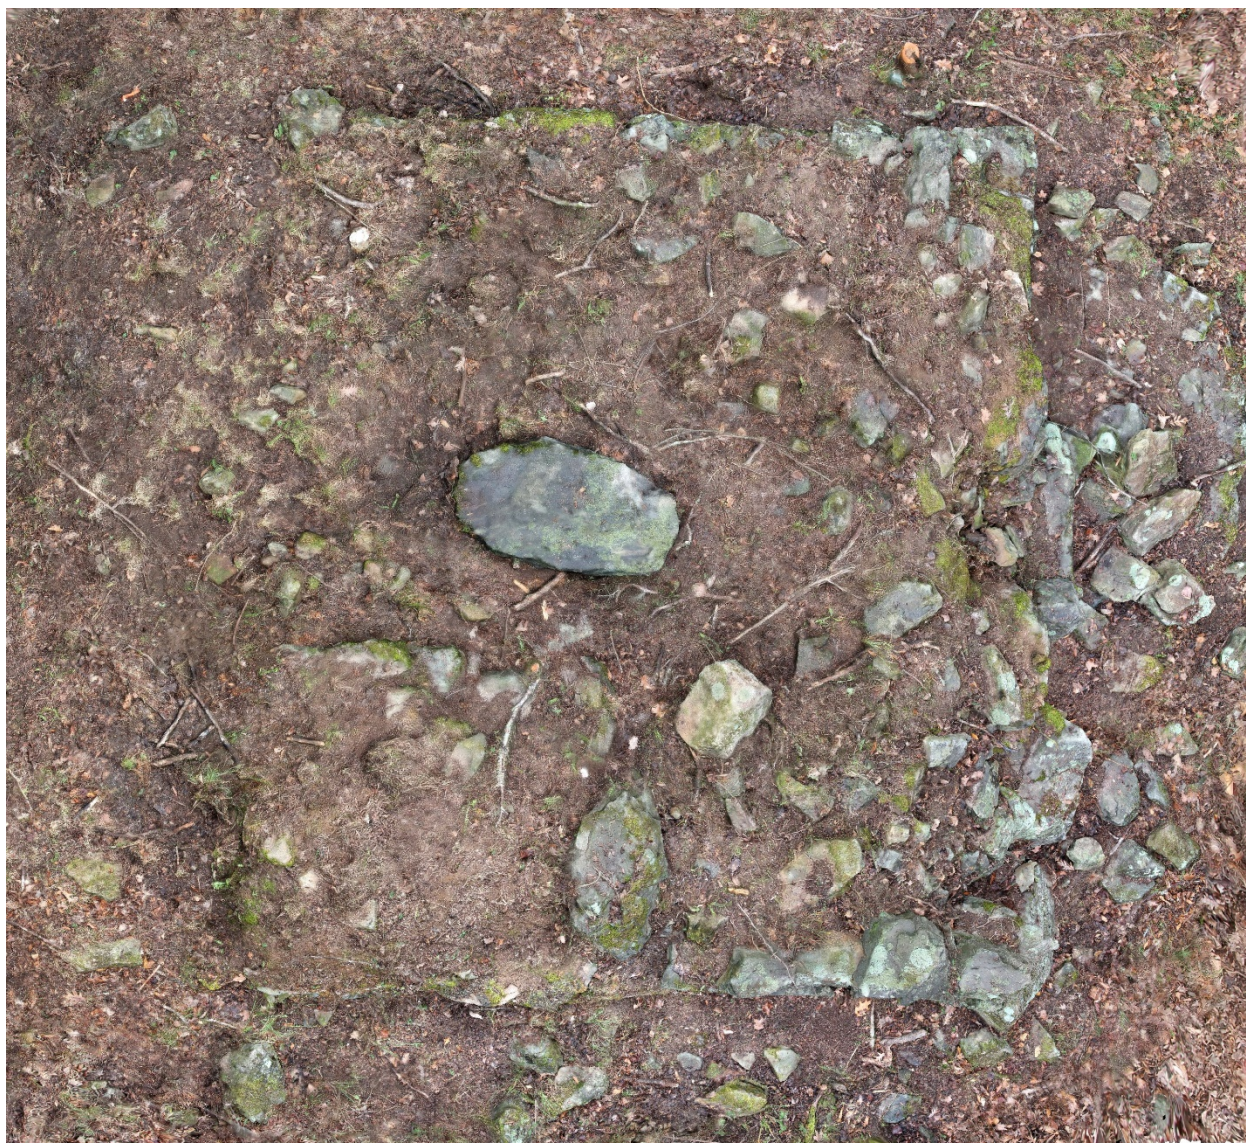
*Figure 34. Structure 9 vertical view northeast at top. Image from 3D model.*

This smaller section of stones could be the remnants of a furnace if this was a blacksmith's shop. At the left edge of the foundation in Figure 34, a narrow rectangle area of rocks appears distinct apart from the structure as a whole. The stones may indicate the presence of a small porch-like overhang attached to the main structure. Archival evidence was discussed that placed blacksmithing at the site, and this structure may have housed that activity. Soil

chemistry testing to determine the presence of slag would be useful to determine if this was in fact a blacksmith's shop. Figure 35 is a view of Structure 9 showing the foundation side closest to the stream.

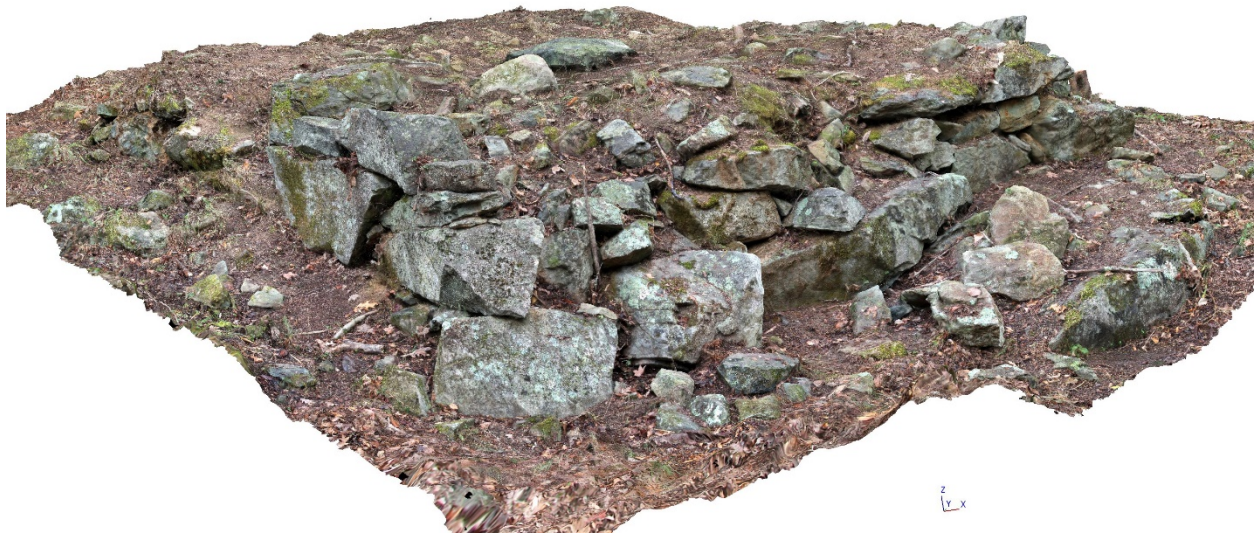
*Figure 35 Structure 9 oblique view to the north. Image from 3D model.*

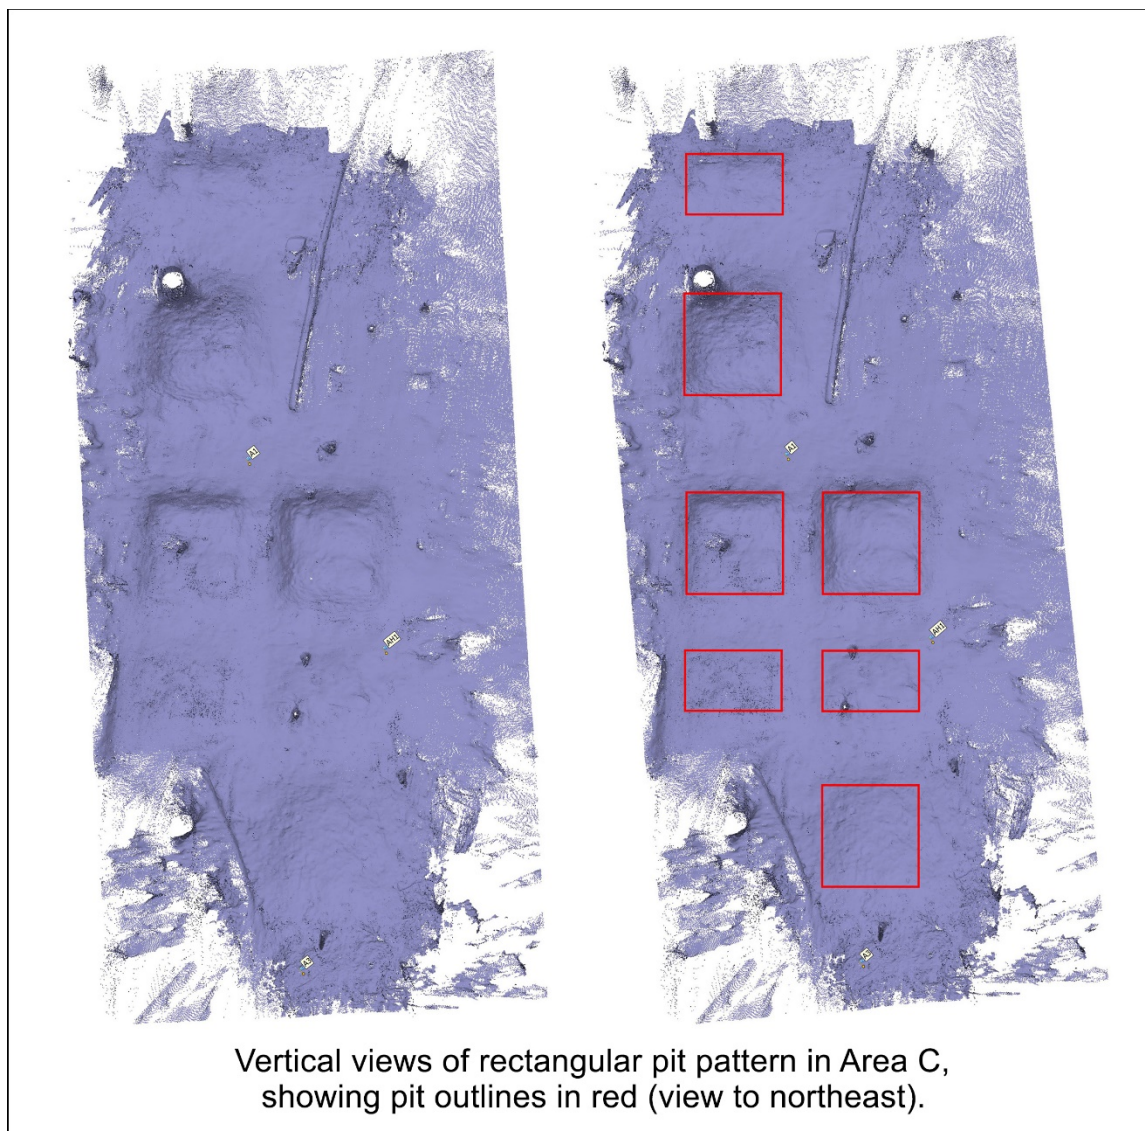
Pits A, E, and G measure 7.4 feet by 4.6 feet (2.25 meters by 1.4 meters). The remaining pits measure 7.4 feet by 7.7 feet (2.25 meters by 2.34 meters). Pits E, F, and G are the furthest south and are the shallowest. These three pits are all less than 1 foot (0.3 meter) deep. The other pits vary in depth from 1 foot (0.3 meter) to just over 2 feet (0.6 meter). Pits C and D have depths that are categorically different from the others. These two pits each have two separate depths within them. The depth variances in these individual pits takes on the appearance of a “step down.” No information could be found related to a tanning function that would require a split-depth pit. The reported pit depths may be less than their original depth due to sediment infill. Pit A, at the north end, opens up toward the creek and may have been used as a drainage pit to empty waste into the creek. Figure 37 (below) is an enhanced copy of a 3D model of the pit structures. The color and texture of the model has been removed in an effort to show the reader the outline and depth of the pits.

*Figure 37. Pits A-G in Structure 10.*

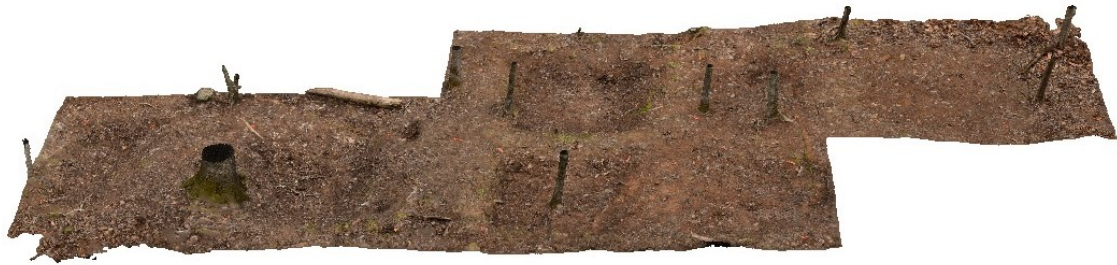
The figures below are used to illustrate the depth of the pit structures. Figure 38 is an oblique view of the pits and Figure 39 is a profile interpretation of Figure 38. The reader should be able to see the depth distinctions of the pits better in Figure 39 than an above-ground photo allows.

*Figure 38. Oblique view of Structure 10 pits. View to the southeast. Image from 3D model.*

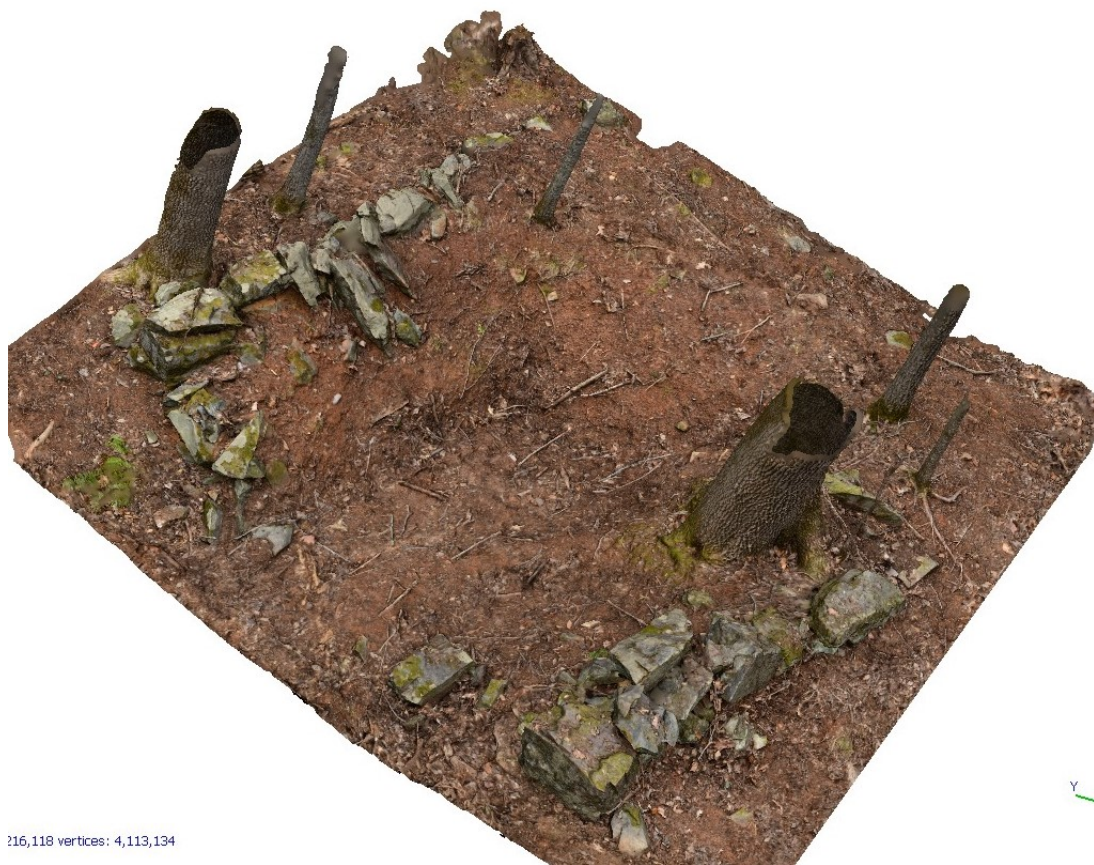
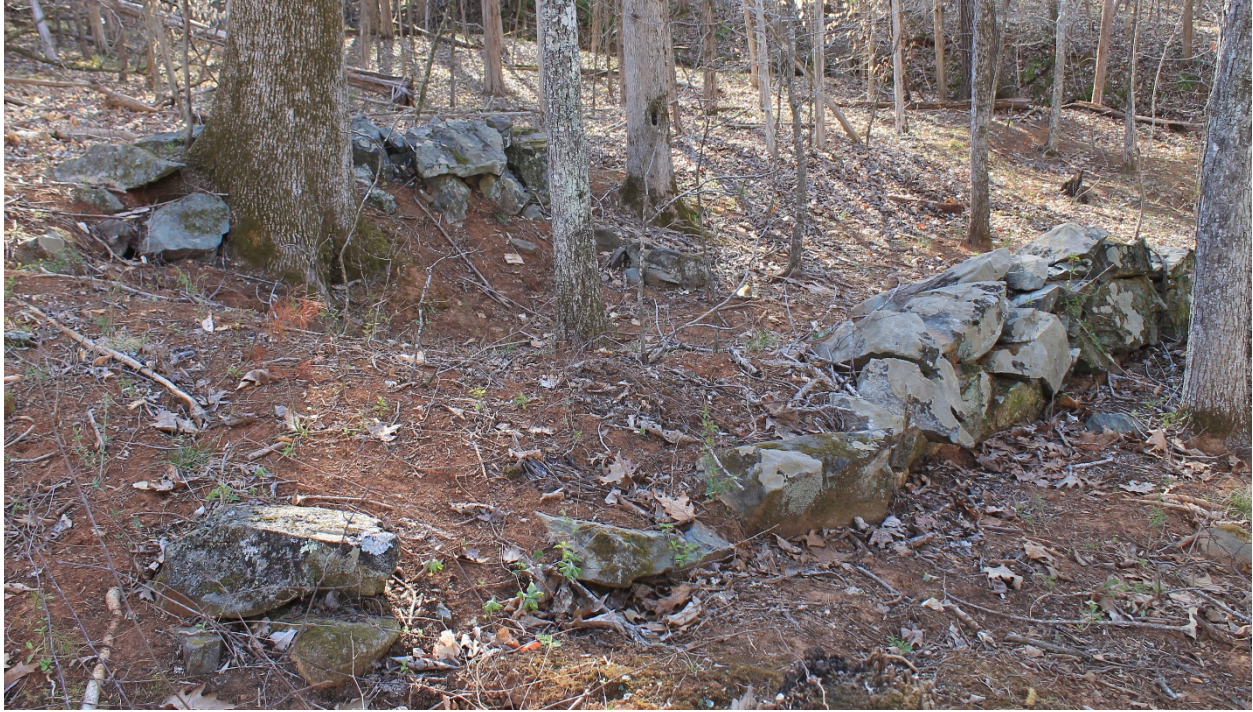
A structure was needed to serve as a beam house for hanging and beaming hides (Welsh 1964:15). Structure 11 could represent a beam house used to hang hides for drying (Figures 40 and 41). Structure 11 is a section of foundation stones representing a building that was 19 feet by 19 feet (5.79 meters by 5.79 meters). It is cut into a hillside and lacks foundation stones on its northwest side, facing the pits. This side is opposite the hill and acts as a natural opening extending off the hill.

*Figure 40. Structure 11 oblique view to the west. Image from 3D model.*

*Figure 41. Structure 11 view to the west.*

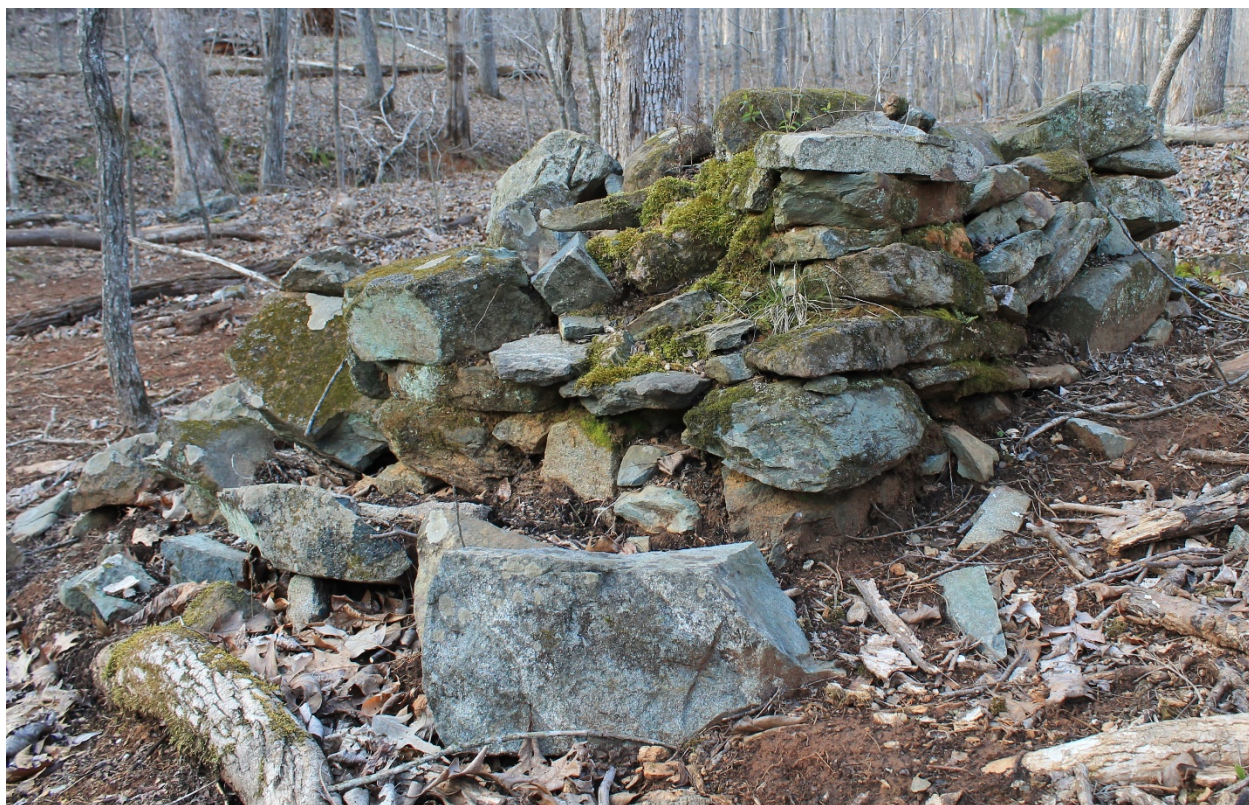
Structure 11 has no evidence of a heat source, but nearby Structure 12 (shown in Figure 42) represents the ruins of a chimney. Only chimney ruins exist without a surrounding structure foundation. Structure 12 is 6 feet by 6.5 feet and is 22 feet north of Structure 11. These two structures could have been used in the tanning operation at the site.

*Figure 42. Structure 12 view to the north.*

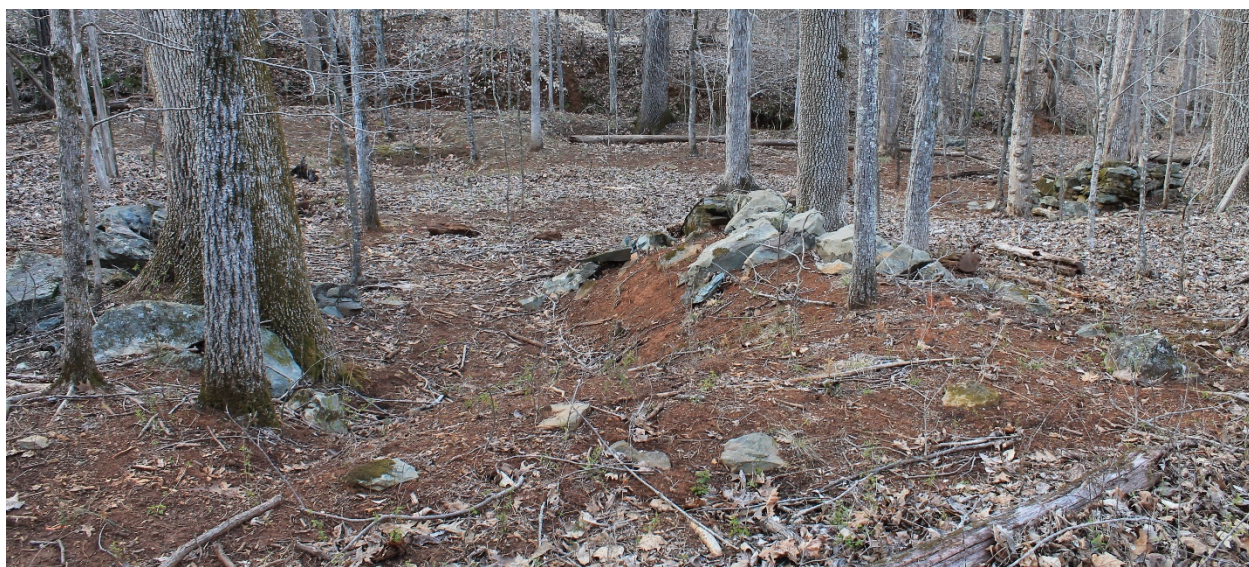
There were very few surface artifacts located at Area C. Half of a charred brick was located beside Structure 10 and one brick was found within the foundation of Structure 12. An alkaline-glazed stoneware sherd was found beside Structure 11. The sherd found here was of the same type and glaze as sherds found in Area A. Figure 43 is a photo taken from the southeast edge of Structure 11 and gives a view of Area C.

*Figure 43. Area C view to the northwest. Photo taken from southeastern edge of Structure 11 looking downhill toward the stream. Structure 12 (chimney ruins) visible on right.*
