SURVEY AND MAPPING OF THE FRED GRAVES SITE:  
LAYING THE GROUNDWORK FOR UNDERSTANDING A RURAL NON-PLANTATION-  
BASED SOUTHERN COMMUNITY

Honors Thesis  
Curriculum in Archaeology  
University of North Carolina at Chapel Hill

2018

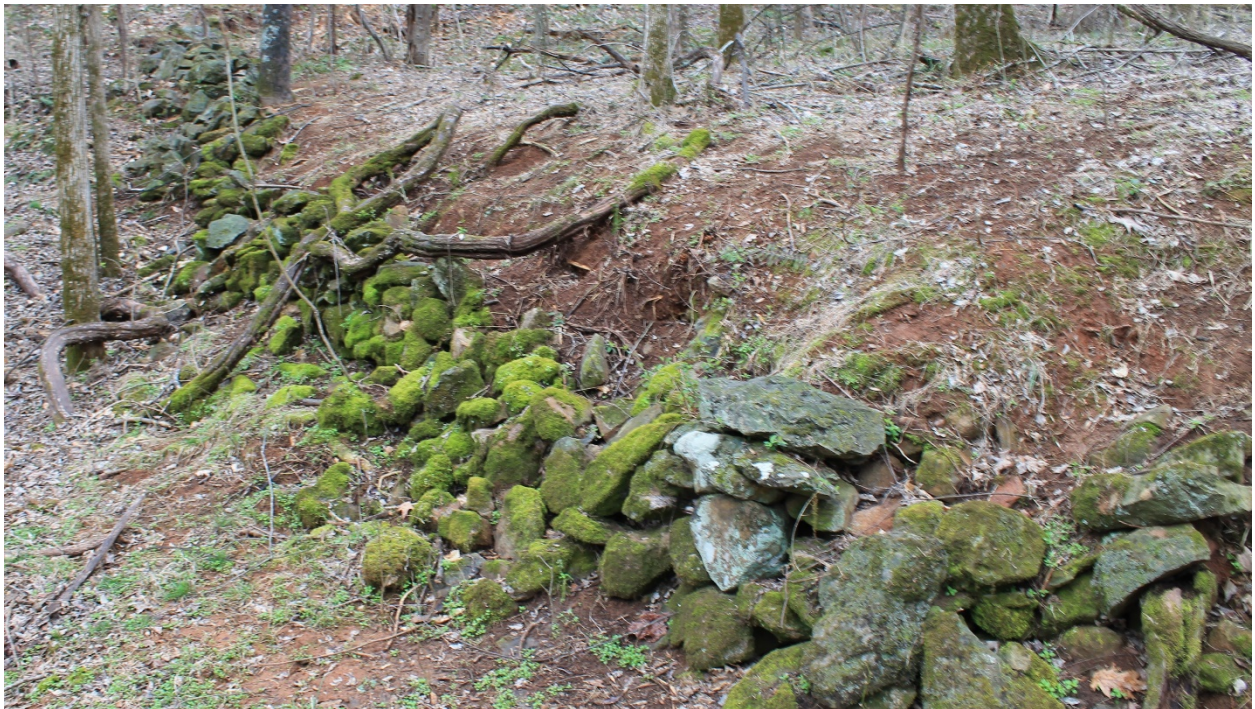
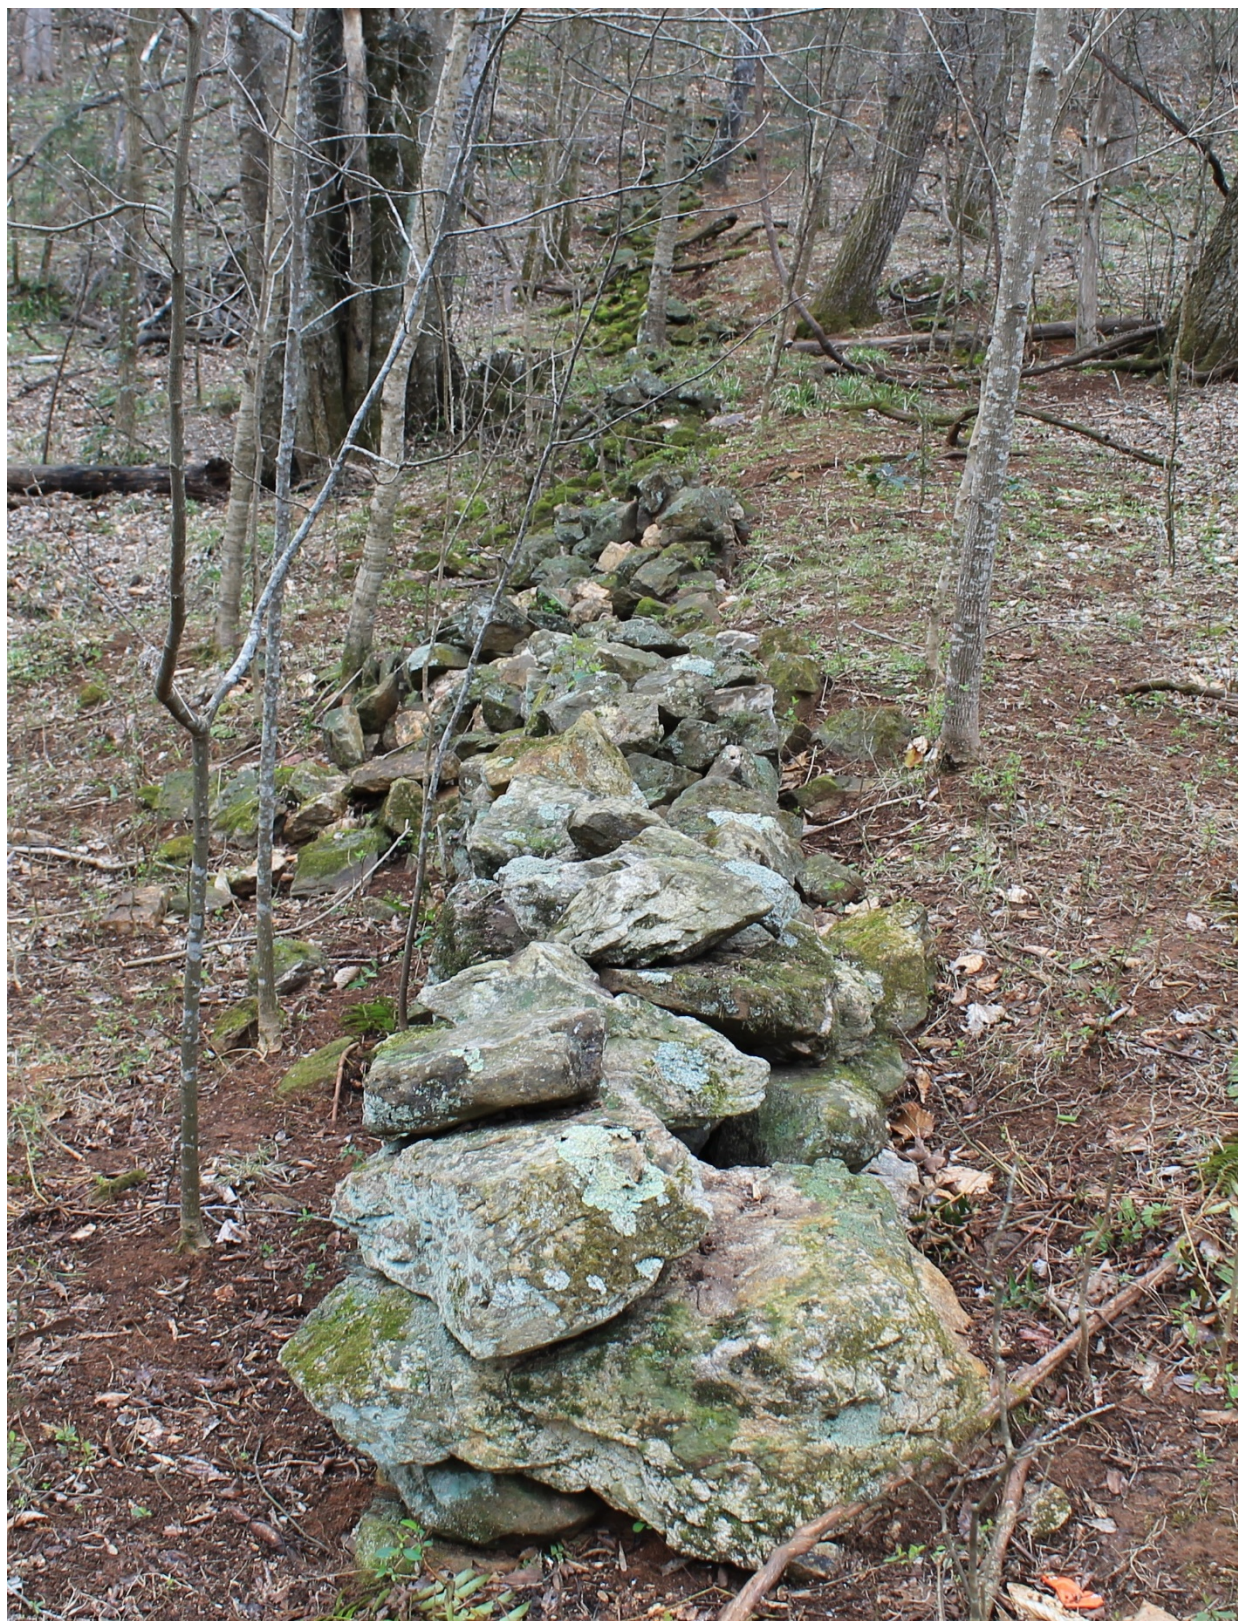
from water runoff to collect against a low wall of stones. As the sediment accumulated, more rocks were stacked and the sediment rose and the wall was built higher to compensate for the sediment collection. This was supposed to have created a level field that would have then been arable.

*Figure 45. Structure 13 view to the south.*

*Figure 46. Structure 13 view to the southeast.*

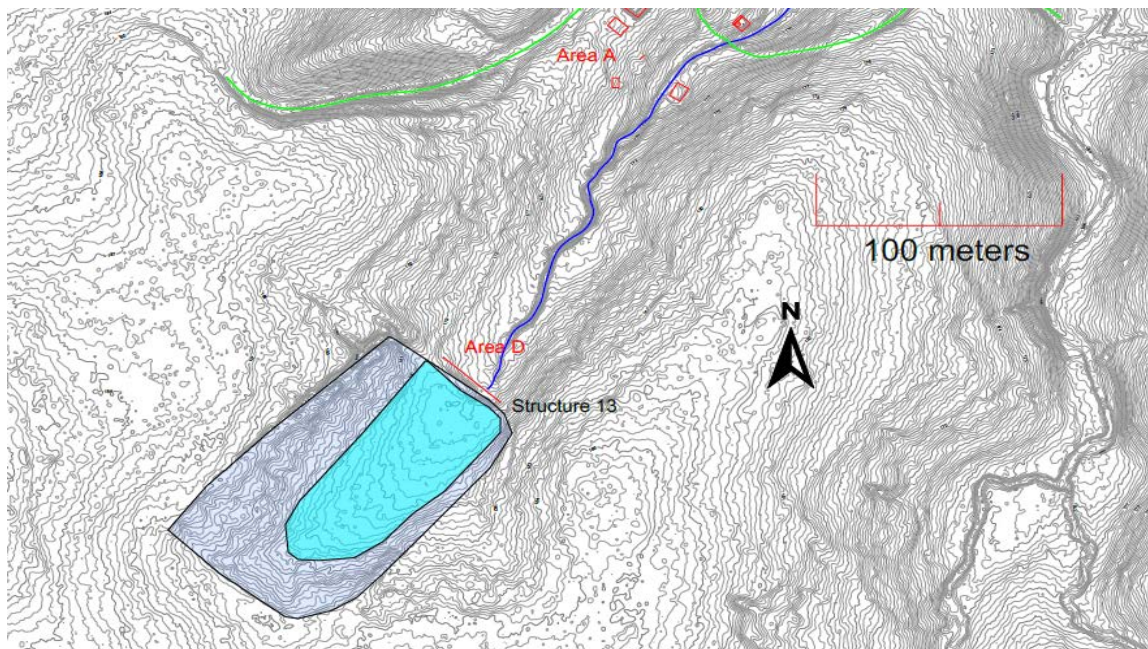
There is another theory for the creation of this wall. When observed on a contour map (Figure 47), this area has a striking resemblance to what might be a former pond. The center of the wall is open and does not appear to be the result of rocks falling from their constructed position. Other areas have fallen and rest just below their original placements. This open section looks like an area of water flow. The V-shaped form is outlined by laid stones. A section from the upper side of the wall looks like a channel possibly made to direct water flow. Below the wall is another line of stones that could have been used to channel water from above, toward the original path of water runoff. If tanning and distilling indeed took place at the site, those activities would have required a constant water supply. The spring may not have been able to supply a sufficient water source for commercial operations. In this case the wall, acting as a low dam, could have created a holding area of water that could be released as needed. Soil cores could be taken from the area above the wall to analyze sediments and determine if the dam hypothesis holds water.

*Figure 47. Contour map of Area D. Possible pond and valley sides colored. Intervals 20 cm.*

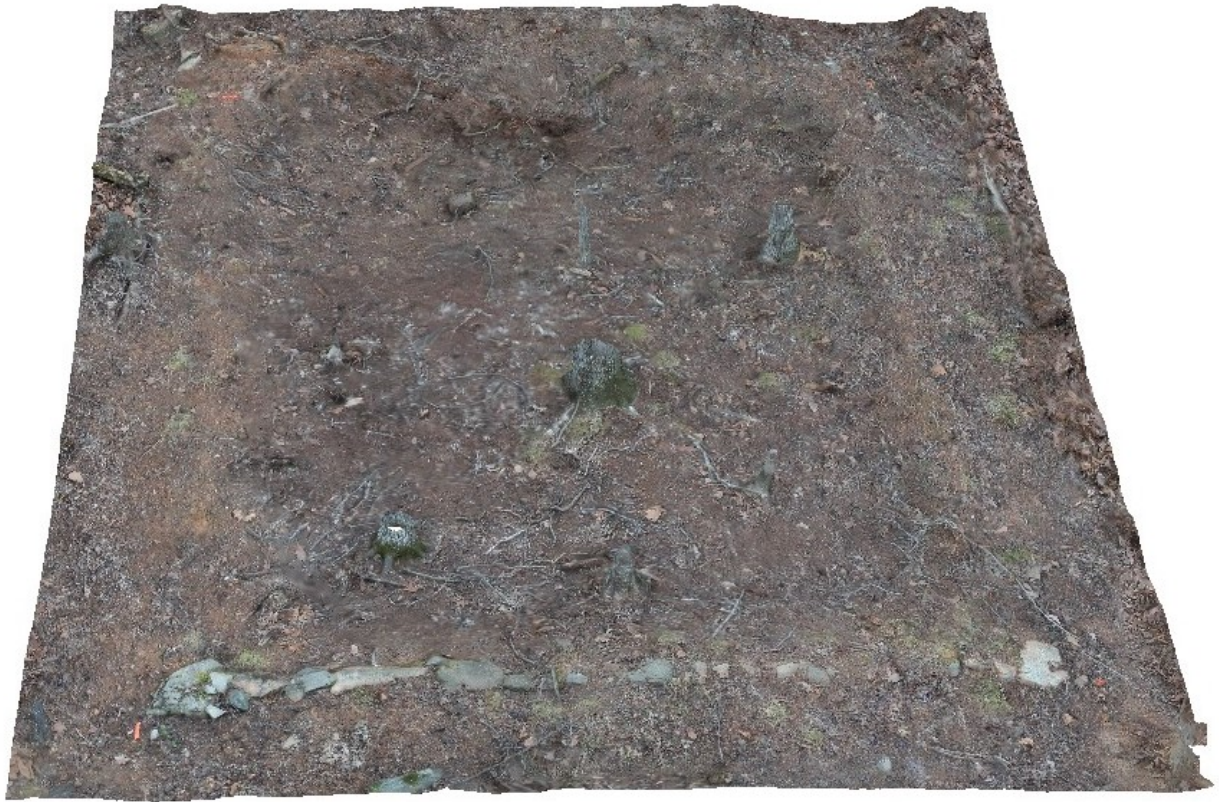
The last structural feature to consider is located at the northernmost area of the site, Area E (Figure 48). Structure 14 is a rectangular depression with a line of stones forming somewhat of a foundation on the northern edge of the depression. This structure measures 24.7 feet by 20.2 feet (7.52 meters by 6.15 meters) (Figure 49). The property owner was aware of this structure and had been told, again by his uncle, that this had been a tobacco barn. No physical evidence can corroborate this assumption but it also cannot be ruled out. Information from the Patterson Store ledger has entries of purchases of tobacco from the Graves family, so it can be known they grew tobacco (SHC 1875). We just do not know where it was grown or cured. Again, chemical testing of the soil here may show evidence as to the nature of this structure's function.

*Figure 49. Structure 14 oblique view to the southwest. Image from 3D model.*

Unlike the other structures and features mapped, Structure 14 is not as accurately located on a map. Its reference points were located using a handheld GPS unit. The unit was accurate within five meters. The distance between the two reference points was altered to reflect the actual distance between the two points. Since the structure was located by using these two points, its location on the map is a close representation but not exact. The orientation of the structure is however, an accurate representation.
