**FRACTURE RESISTANCE AND SURFACE TREATMENT OF Y-TZP PREPABLE
CERAMIC ABUTMENTS AND BARS**

A thesis submitted to the faculty of the University of North Carolina at Chapel Hill in partial fulfillment of the requirements for the degree of Master of Science in the Department of Prosthodontics.

Chapel Hill
2006

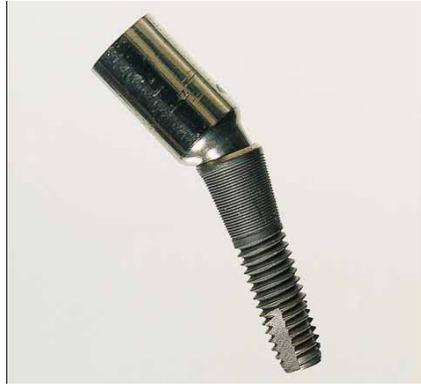
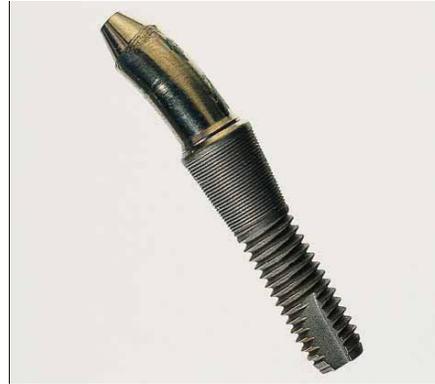
Figure 2.1 Titanium abutment designs used to evaluate failure modes (Norton, 2000).

(a) Two piece, deformation at internal hex.

(b) One piece, deformation at body of abutment.

In another study (Norton, 2000b) the abutment design was evaluated by comparing one-piece versus two-piece conical abutments (see Figure 2.1). Although one- and two-piece abutments had similar critical zones, their modes of failure were different. For one-piece abutments, failure involved the cylindrical part of the solid titanium abutments. In two-piece abutments, failure occurred at the head of the screw or at the internal hexagon at the base of the abutments.

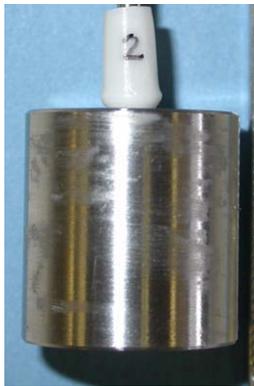
Figure 3.8 Abutment assembly fixed within implant analog with Field's metal.

For testing, each analog was first positioned with a stainless steel cylinder with its neck parallel to the top of the cylinder and fixed in place using Field's metal alloy (www.scitoys.com). Abutments were then connected to implant analogs using a torque of 25 N-cm (Astra Tech torque wrench). This combination is referred to as the assembly or implant assembly (Figure 3.7). The cylinders with assemblies were placed onto a stainless steel fixture which was inclined at 30° to the vertical in preparation for loading (Figure 3.9) in a universal testing machine (Instron, Model 4411, Grove City, PA).
