## **Abstract**

The cliffs above the public beaches of the Conero Riviera between Ancona and Portonovo, Italy, are comprised of sedimentary rocks and are subject to copious rainfall and occasional earthquakes. The area has experienced large-scale landslide events, from Portonovo's 14th century landslide to Ancona's more recent 1982 landslide. Though these events have been studied at length, there are no studies on this region's risk of future landslides. Based on the historical and geological evidence, it is important that the Ancona coastline be assessed for landslide risk. This study aimed to determine the role of geologic structures in the area near these two historic landslides using kinematic analysis as well as structural and stratigraphic field data collected between the Ancona shipyard and the southernmost accessible beach of Monte Conero. We collected data from within several different rock units and observed distinct patterns of jointing, faulting, and bedding along the coast. Some of these structures show risk of planar and wedge failure. There is evidence of recent rockfalls and landslides, all of which were smaller than the two historical slides. We conclude that the

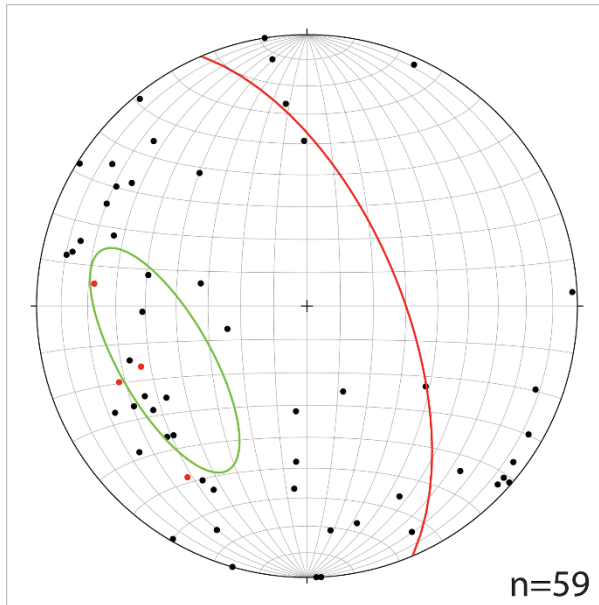
**Location 1c.**  
Figure 8c

Figure 8a-8f Planar failure analysis for locations 1a-d, 2, 4, and 5. Poles to structures (black), poles to cliff face (red) and average cliff face (red plane) for each location. Structures oriented for failure are circled in green. The failure planes in Figure 8f are bedding. All other planar failure planes are joints.

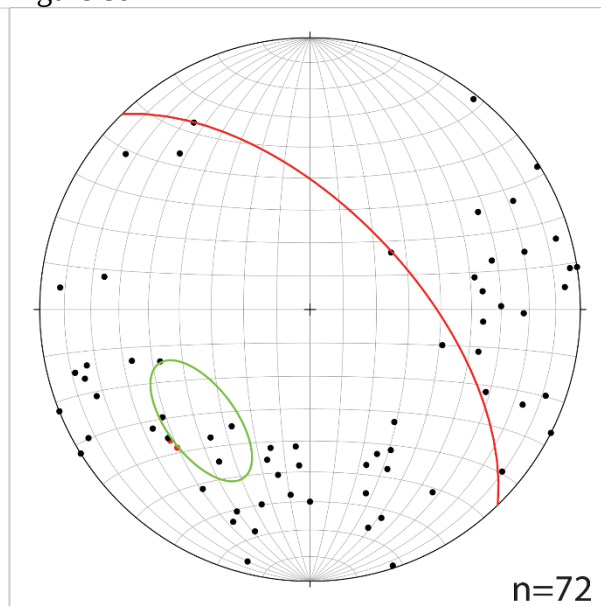
**Location 4.**  
Figure 8f

The landslide that partially covers location 3 also covers the upper part of location 4. While location 4 has planes oriented for both wedge and planar failure, these features are only exposed near the bottom of the cliff. They are not seen further up on the cliff. The current landslide deposit would have to be eroded away entirely to reveal a fresh cliff face before wedge or planar failure could occur from the top of the cliff. The nature of slides in the immediate future will be rockfalls from less than 15m height.

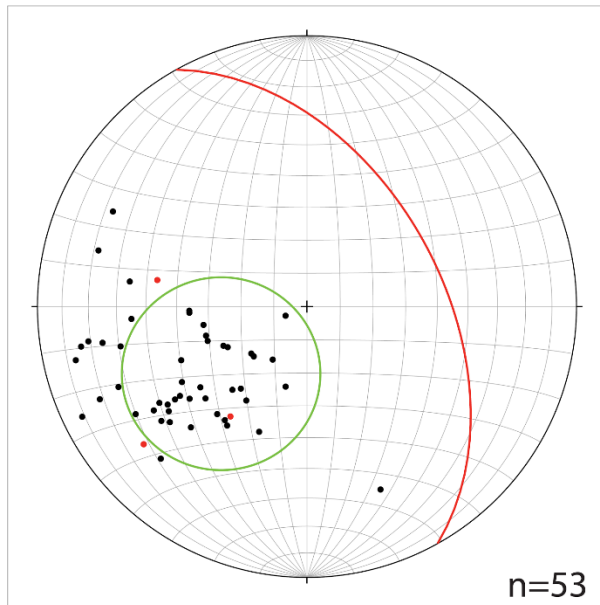
Figure 8g

Location 5 shows risk of planar failure along bedding planes. There are detachment scars up to approximately 275m elevation above hundreds of square meters of exposed bedding planes

(Figure 12). While this region is at risk of both planar and wedge failure, the majority of failure planes are oriented for planar failure. Almost all of the bedding planes are oriented for planar failure, while only about one third of the joints and stylolites are oriented for wedge failure. Thus, a planar failure slide is more likely to occur here than a wedge failure slide. This area is susceptible to cobble to boulder sized pieces of rock as well as large sheets of bedding plane-failing from high elevation. Since the cliffs here are much higher than anywhere else in the study area, location 5 could produce a slide of a much larger volume of rock than the other locations exhibiting two failure types.

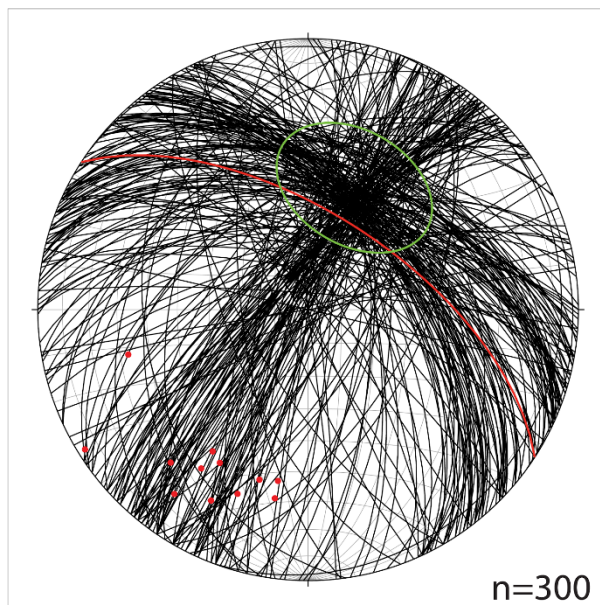
Figure 8h

Figure 8h-8m Wedge failure analysis for locations 1a-d and 4. Planes of structures (black), poles to cliff face (red) and average cliff face (red plane) for each location. Intersections lines of structures oriented for failure are circled in green. All wedge failure planes are joints except for Figure 8m--these are joints and stylolites.
