## FINAL REPORT FOR A1900

MSE

11 July 2003

Year 2003 Trench/Locus ~~A1800~~ A1901 Excavator MSE

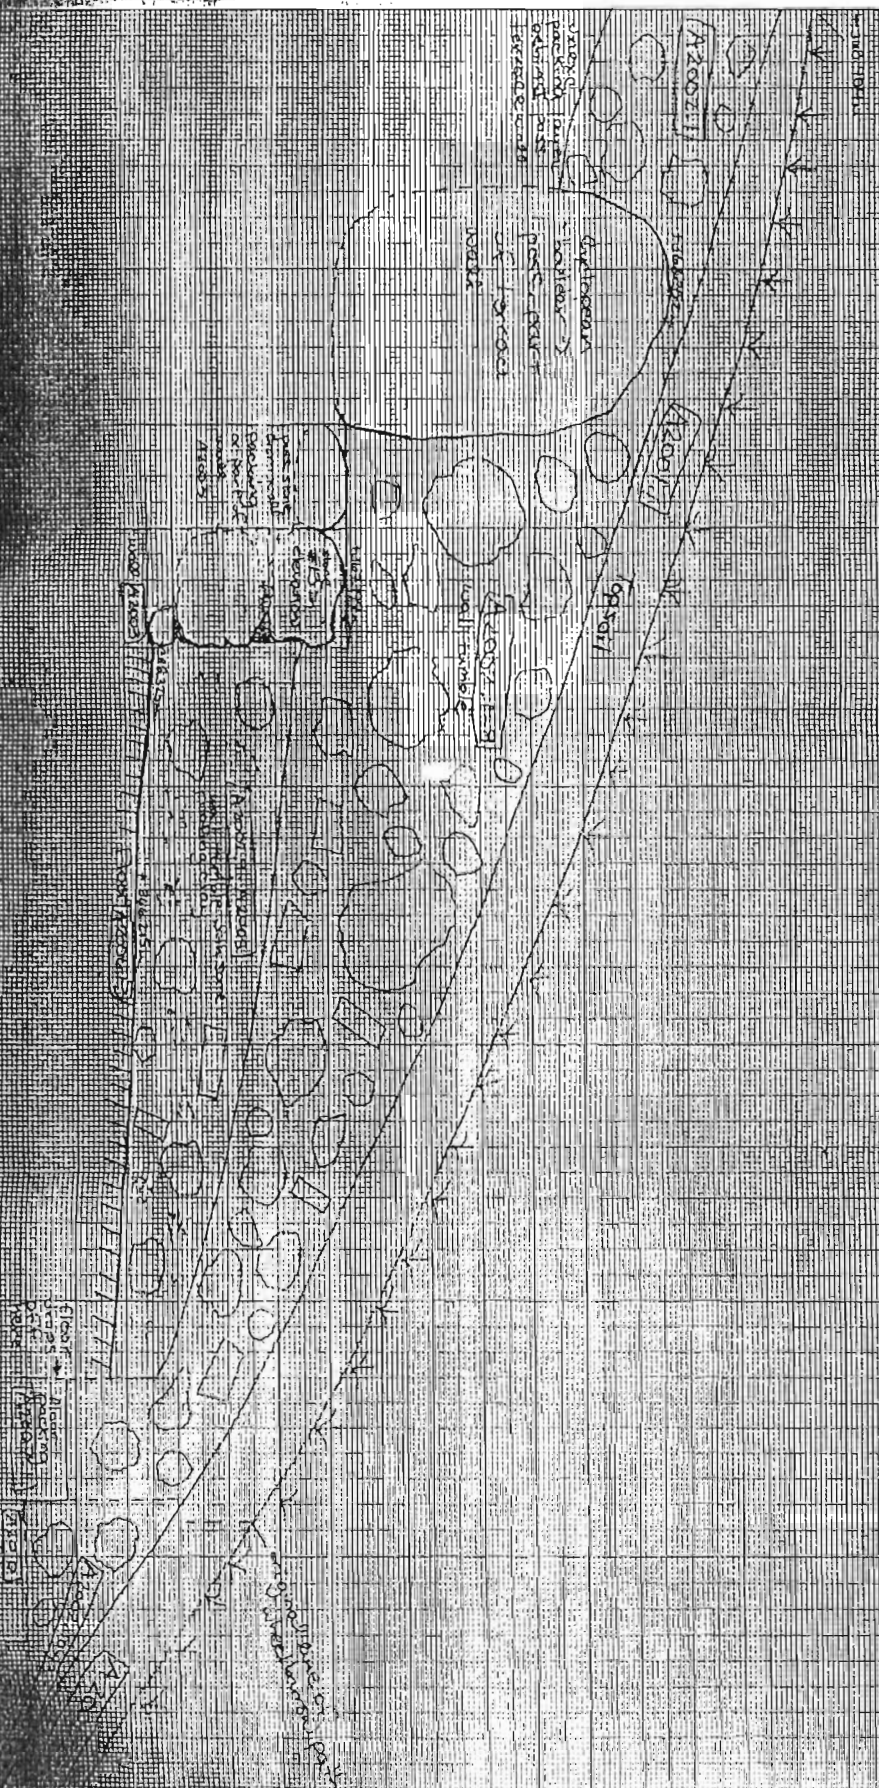
(365.74m)  
Elevations  
Benchmark used: R4  
Reading on  
Benchmark: 3.801m  
H.I.: 369.541m

opening elevations  
1-2.075 → 367.466m  
2-0.727 → 368.814m  
3-0.063 → 369.478m  
4-0.348 → 369.193m  
5-1.313 → 368.228m  
6-2.261 → 367.280m  
7-3.210 → 366.331m  
8-1.993 → 367.548m  
9-0.535 → 369.006m

closing elevations  
1-3.056 → 367.457m  
2-1.962 → 368.531m  
3-1.035 → 369.458m  
4-1.375 → 369.118m  
5-2.404 → 368.089m  
6-4.310 → 366.183m  
7-4.265 → 366.228m  
8-3.171 → 367.322m  
9-1.898 → 368.595m

South of A800, north edge begins w/ north (revealed) face of wall A812; borders A2000 to south; to east are Boyd excavations (circular structure) & in A800

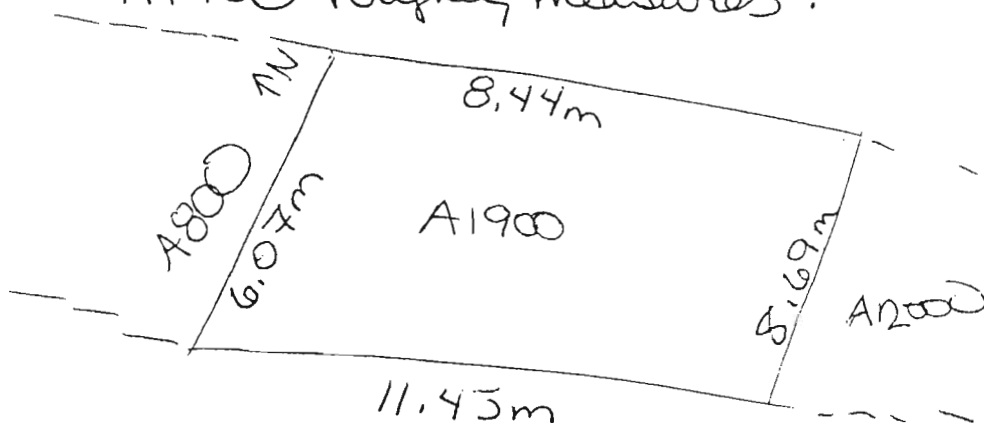
A1900 roughly measures:

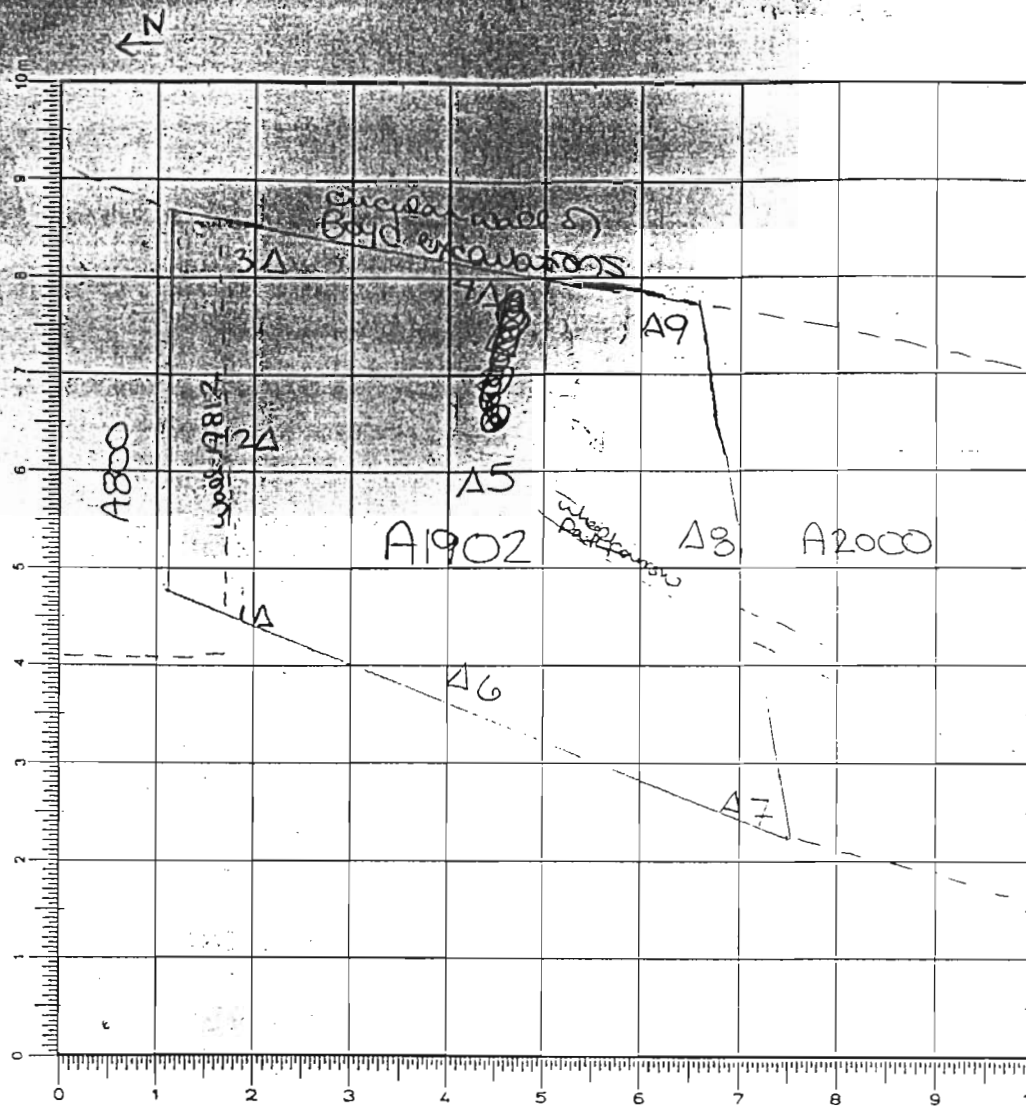
SKETCH ~~1902~~

Benchmark used: R4  
 Reading on  
 Benchmark: 4.753  
 H.I.: 370.493m

- 1- 367.457m
- 2- 368.531m
- 3- 369.458m
- 4- 369.118m
- 5- 368.089m
- 6- 366.183m
- 7- 366.223m
- 8- 367.322m
- 9- 368.595m

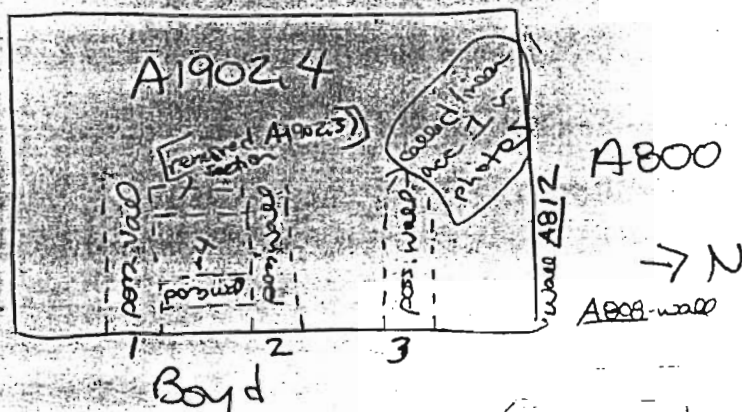
coiled  
linear  
accumulations  
in photographs

all possible  
walls to be  
further investigated  
in future passes

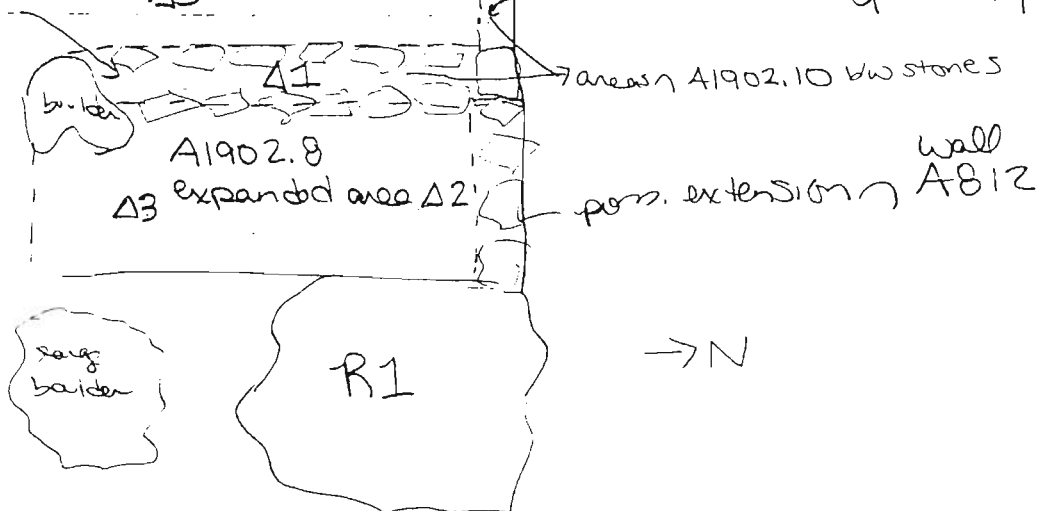
poss.  
back  
wall

1 June 03 - elevations taken after A1902.8 → see p. 5  
for <sup>locator</sup> sketch (R1 → 1.127) HI-371,747

Δ1 - 2.175 → 369.572m

Δ2 - 2.144 → 369.603m

~~Δ2~~ Δ3 - 2.143 → 369.604m

Δ1 taken in b/w lines of  
stones → unclear if either  
is part of the wall  
(back/road)

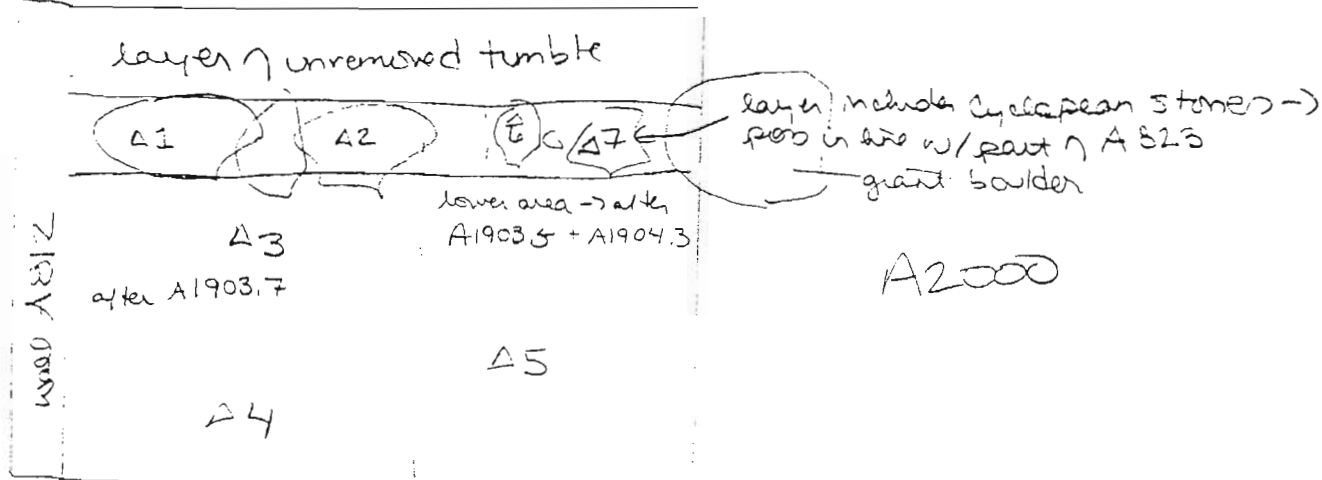
- R1 - 0.522 - cyclopean stones may actually be back wall  
 $\Delta 1 - 2.787 \rightarrow 368.355m$   
 $\Delta 2 - 2.572 \rightarrow 368.576m$  (part of A823)  
 $\Delta 3 - 3.766 \rightarrow 367.376m$   
 $\Delta 4 - 3.838 \rightarrow 367.304m$   
 $\Delta 5 - 4.231 \rightarrow 366.911m$   
 $\Delta 6 - 2.688 \rightarrow 368.454m$   
 $\Delta 7 - 2.718 \rightarrow 368.424m$

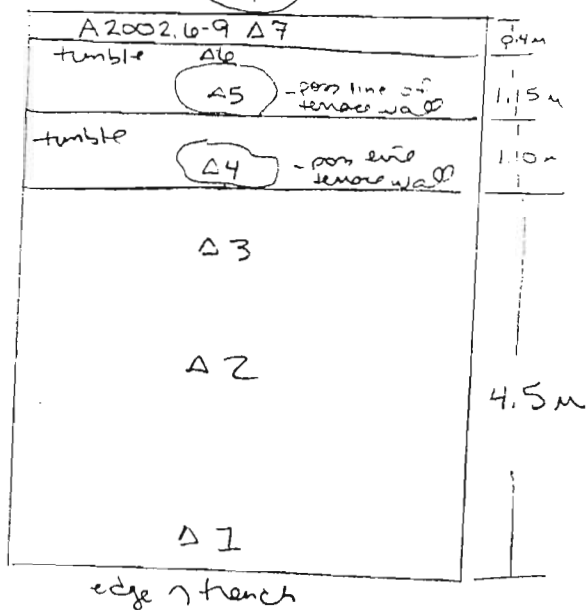
9 July closing elevations - area of section E-W

- R4 - 2.928  
 H1 - 368.668m  
 $\Delta 1 - 1.447 \rightarrow 367.221m$   
 $\Delta 2 - 1.316 \rightarrow 367.352m$   
 $\Delta 3 - 1.298 \rightarrow 367.370m$   
 $\Delta 4 - 0.176 \rightarrow 368.492m$   
 R1 - 1.087  
 H1 - 371.707  
 $\Delta 5 - 2.316 \rightarrow 369.391m$   
 $\Delta 6 - 2.045 \rightarrow 369.662m$   
 $\Delta 7 - 2.283 \rightarrow 369.424m$

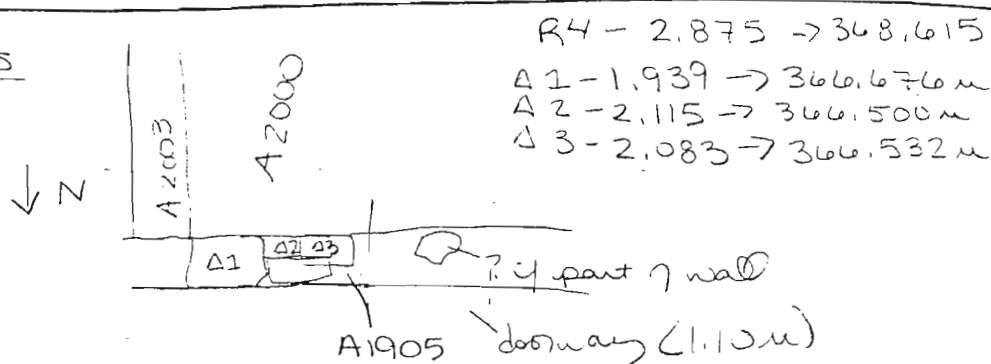
elevations

26 June 03 current length ~ 2.70m (new stones exposed after ~~A2005.7~~ A2002.13)

wall has slipped somewhat down hill and so many stones are somewhat diagonal

⇒ doorway found in wall

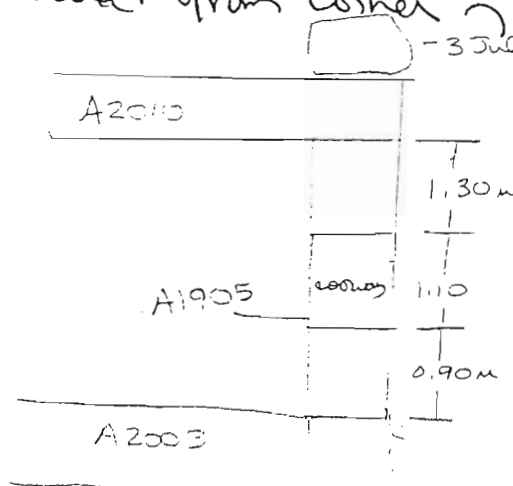
stones have fallen into doorway

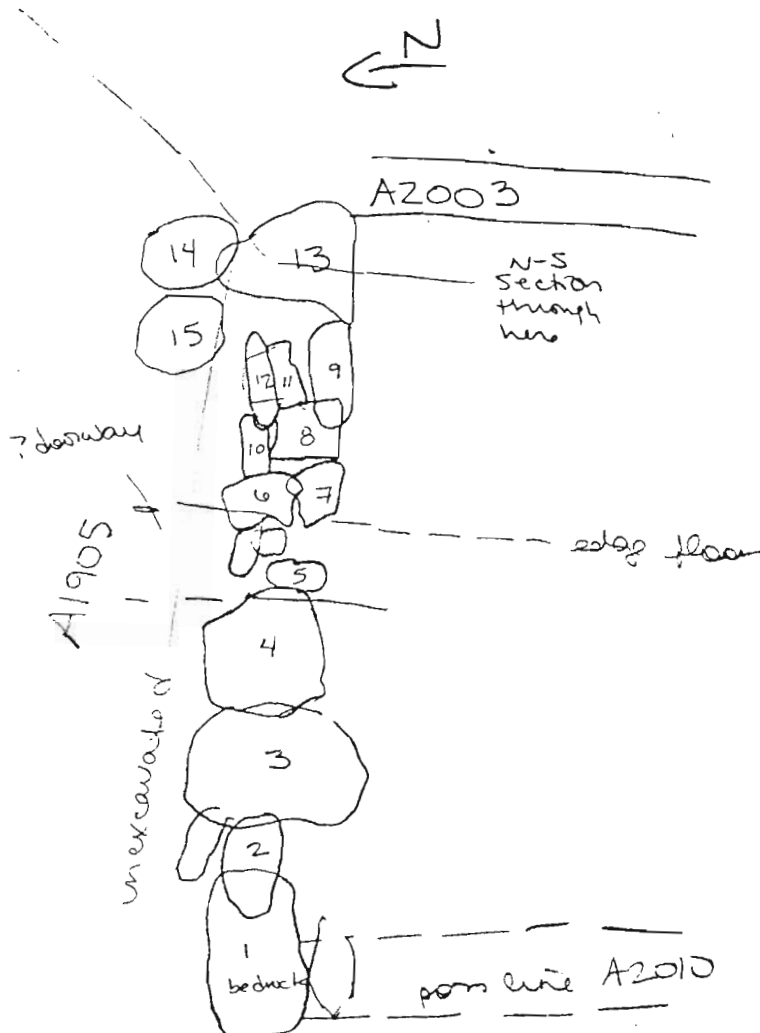
- 1- 3.565 → 365.103m
- 2- 3.385 → 365.333m
- 3- 3.134 → 365.534m
- 4- 2.687 → 365.981m
- 5- 2.517 → 366.151m
- 6- 2.232 → 366.436m
- 7- 2.245 → 366.423m
- 8- 2.125 → 366.543m
- 9- 2.177 → 366.491m
- 10- 2.132 → 366.536m
- 11- 2.172 → 366.496m
- 12- 2.054 → 366.614m
- 13- 2.000 → 366.668m
- 14- 1.975 → 366.693m
- 15- 2.027 → 366.641m

The wall appears to extend below the level of the floor (A2006, 1+2)
