## Azoria Project 2006

Excavator: RCM

### D700 FINAL REPORT

**Purpose of excavation:** Opening of trench on northwest slope, a previously unexplored area of site with ancient walls visible on the surface on the east and west edges of the terrace; defining use of terrace north of civic complex.

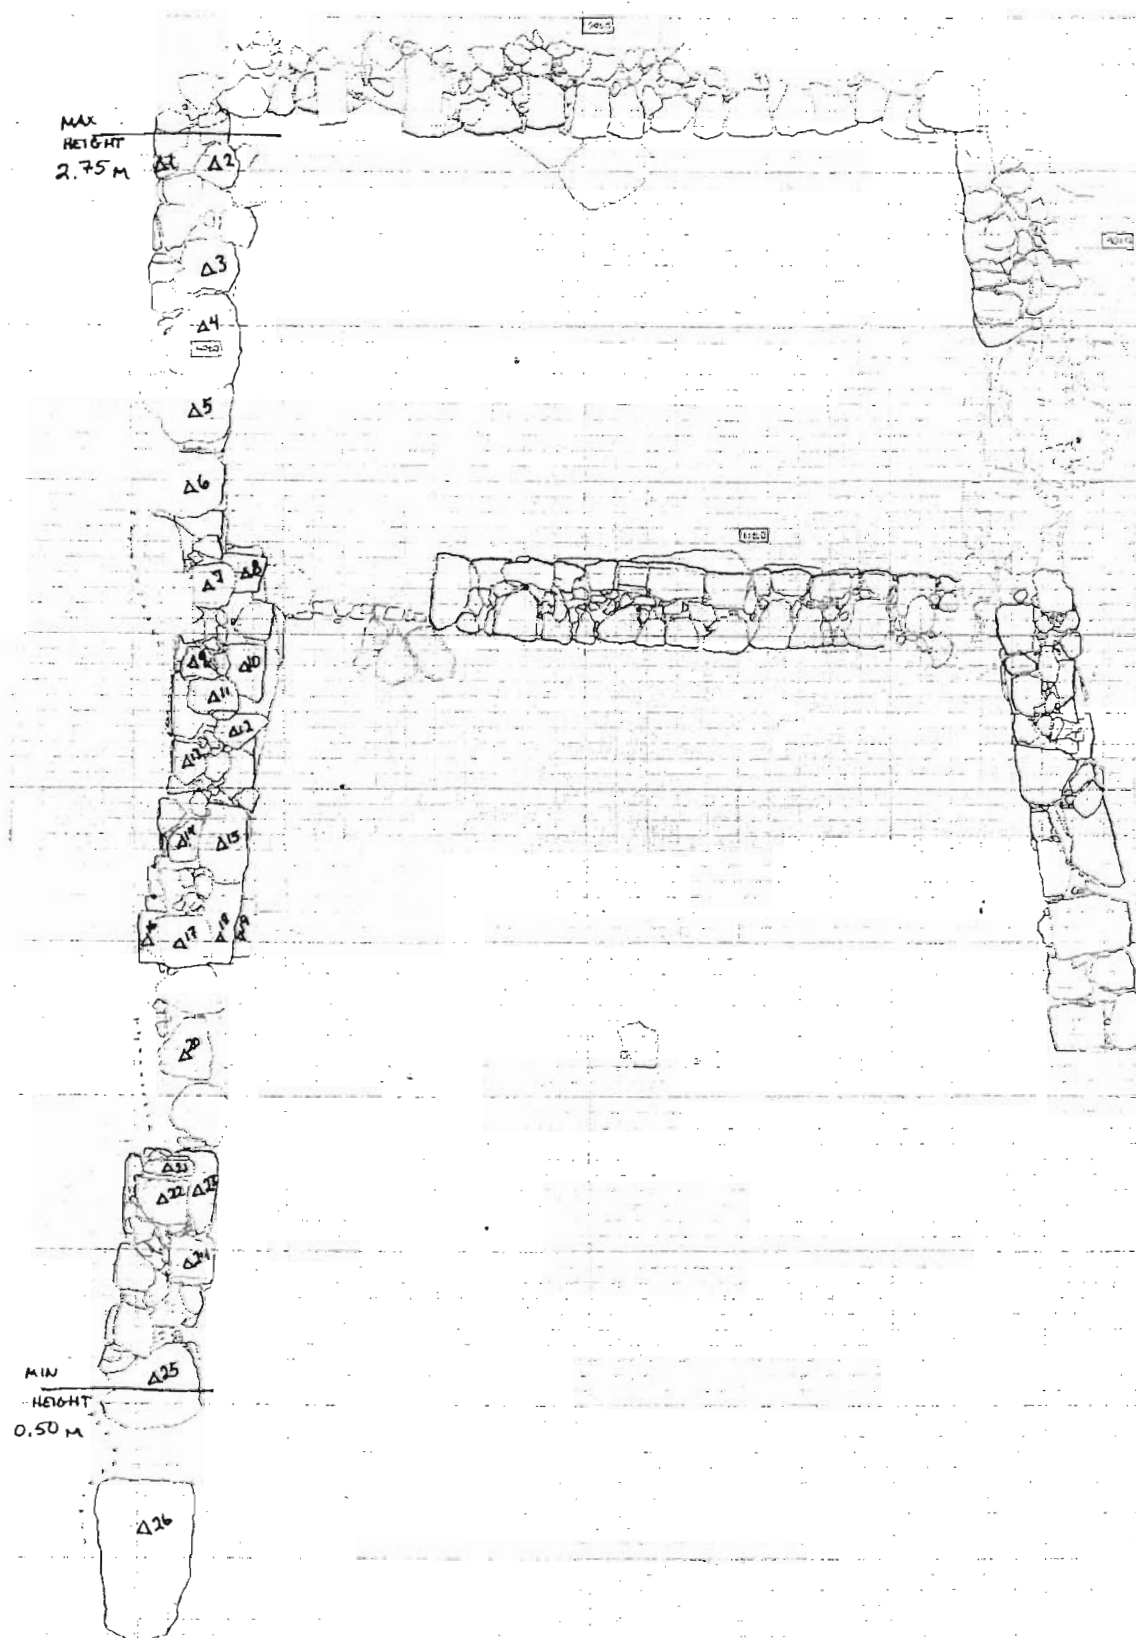
Verbal description: 18 JULY 06 WALL D704(N) HAS A FINAL PRESERVED HEIGHT OF 2.75 M (MAX) AND MIN. PRESERVED HEIGHT OF 50 CM (ALONG W EDGE). CONSTRUCTION IS MIXED - BEDROCK FOUNDATION TO EXTREME E BELOW LARGE (>30 CM) STONES. COURSE ABOVE INCLUDES STONES SMALLER THAN 30 CM, PROBABLY FOR LEVELING PURPOSES, ~~AS~~ SINCE NEXT COURSE INCLUDES STONES 40 CM + WITH ROUGHLY RECTILINEAR SHAPE. W PORTION OF WALL, BEYOND TRANSITION MARKED BY DOORWAY, FEATURES HIGHLY VARIABLE CONSTRUCTION; BOTTOM COURSE BETWEEN ~~W/~~ BLOCKED DOOR TO N AND DOORWAY TO E ROOM INCLUDES BOULDER ~ 1M LONG, ~~W/~~ W/ ~~N/A~~ IRONSTONE COURSES FILLING THE AREA ABOVE. WALL JOGS S TO FORM DOORJAMB LEADING INTO E ROOM - WORKED RECTILINEAR STONES V. WELL-FACED ARE USED TO FORM THE CORNER. JAMB OF BLOCKED DOOR PRESERVED TO 5 COURSES ON E SIDE + 3 ON W. CONSTRUCTION ON W SIDE OF BLOCKED DOOR REVERTS TO IRONSTONE ABOVE ROUGHLY WORKED BOTTOM COURSES. WALL EXCAVATED TO FLOOR LEVEL ALONG ENTIRE LENGTH.

- D704: North wall. Length: 10.20 m; max. height: 2.75 m; min. height: 0.50 m.
- D705: East wall. Length: 5.35 m; max. height: 2.86 m; min. height: 1.80 m.
- D706: South wall. Length: 10.40 m (?); max. height: 2.67 m; min. height: 0.25 m.
- D711: Crosswall running north from D706, dividing east and west rooms. Length: 5.70 m; max. height: 0.35 m; min. height: 0.17 m.
- D717: Remnants of ancient wall running north-south along edge of terrace, visible below west scarp and continuing beyond trench borders. Length: >7 m; max. height: 0.70 m; min. height: 0.25 m.
- northeast plaka* – in situ on floor near center of wall D705 (E). ~50 x 50 cm, roughly triangular.
- southwest plaka* – in situ on floor near center of wall D705 (E). ~44 x 56 cm, roughly rectangular.
- quern*(?) – in situ in SE corner, east room. ~20 x 20 cm, roughly rhomboidal.

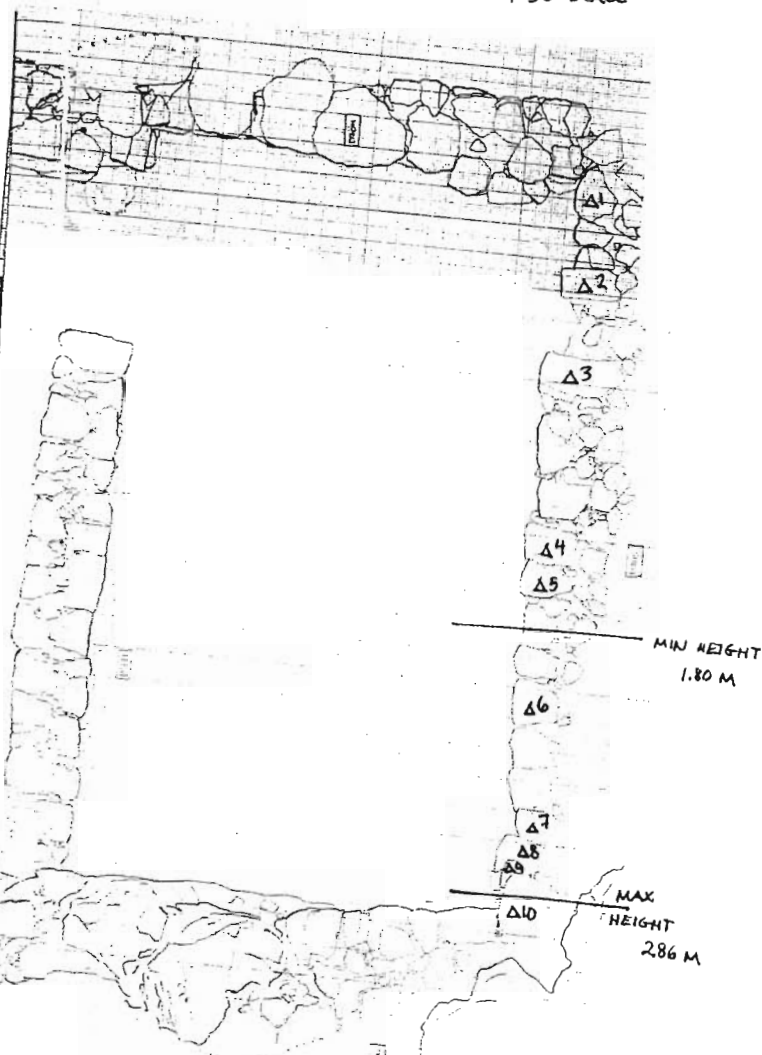
Verbal description: 19 JULY 06 WALL D705 (E) HAS A FINAL PRESERVED HEIGHT OF 2.86 m (MAX) AND MIN. HEIGHT OF 1.80 m. IT IS FOUNDED ON BEDROCK WHICH SLOPES UP ON EITHER END AND ACCOUNTS FOR LEVEL OF PRESERVATION. BOTTOM COURSE IS COMPOSED OF V. LARGE (70-80 CM) ~~REGULARLY~~ <sup>WHERE USED TO</sup> IRREGULARLY SHAPED BOULDERS; STONES BECOME PROGRESSIVELY SMALLER IN COURSES ABOVE AND ~~FILL~~ <sup>WHERE USED TO</sup> GAPS ~~BETWEEN STONES~~ <sup>BETWEEN STONES</sup> IN LOWER COURSES. LARGE STONES ALSO USED IN ~~MINOR~~ <sup>N CENTRAL</sup> AREA SO THAT ONLY ONE COURSE OF STONES OF EQUAL SIZE IS PRESERVED. (SECTION DRAWN IN AREA OF ~~THESE~~ <sup>N CENTRAL</sup> LARGE, HIGH STONES.) 6 COURSES PRESERVED AT MIN HEIGHT; AS MANY AS 10 ELSEWHERE (AREA OF MAX HEIGHT IS PARTIALLY FOUNDED ON BEDROCK. EXCAVATED TO FLOOR LEVEL ACROSS ENTIRE LENGTH.

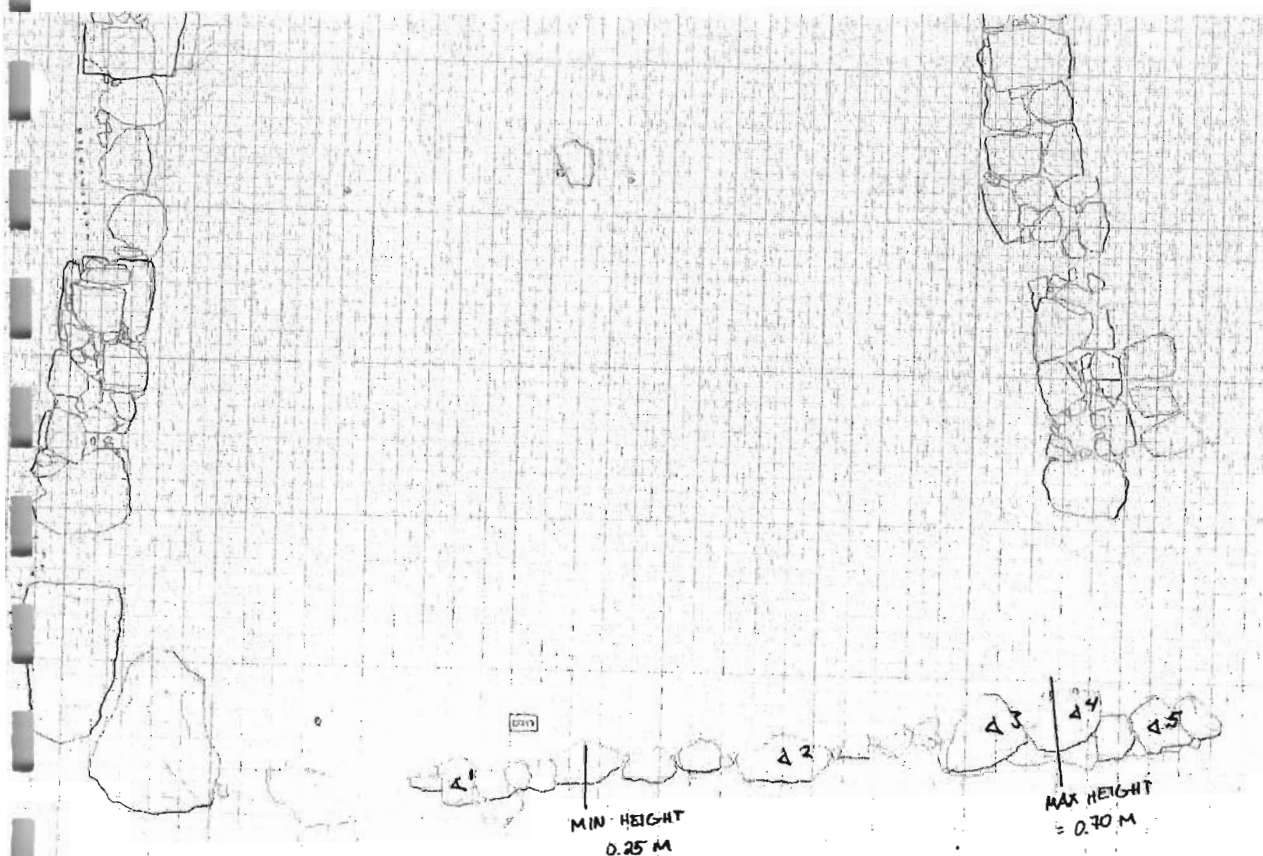
THIS IS A WALL, THE W WALL OF TRENCH D700 (?) PRESERVED AT FOUNDATION LEVEL ONLY; WAS EITHER ~~CHUNK~~ WAS SITUATED ON EDGE OF TERRACE DOWNLING AS TERRACE WALL, OR REST OF W SLOPE HAS ERODED. LARGE IRREGULAR STONES USED (MOSTLY 30 CM+) AND CURRENTLY PRESERVED NO HIGHER THAN TWO COURSES, ALTHOUGH A AREA REMAINS UNEXCAVATED AT CLOSE OF SEASON.
